# SouthHill Redevelopment

## Inventory & Analysis

# Southhill Student Complex

Task 2

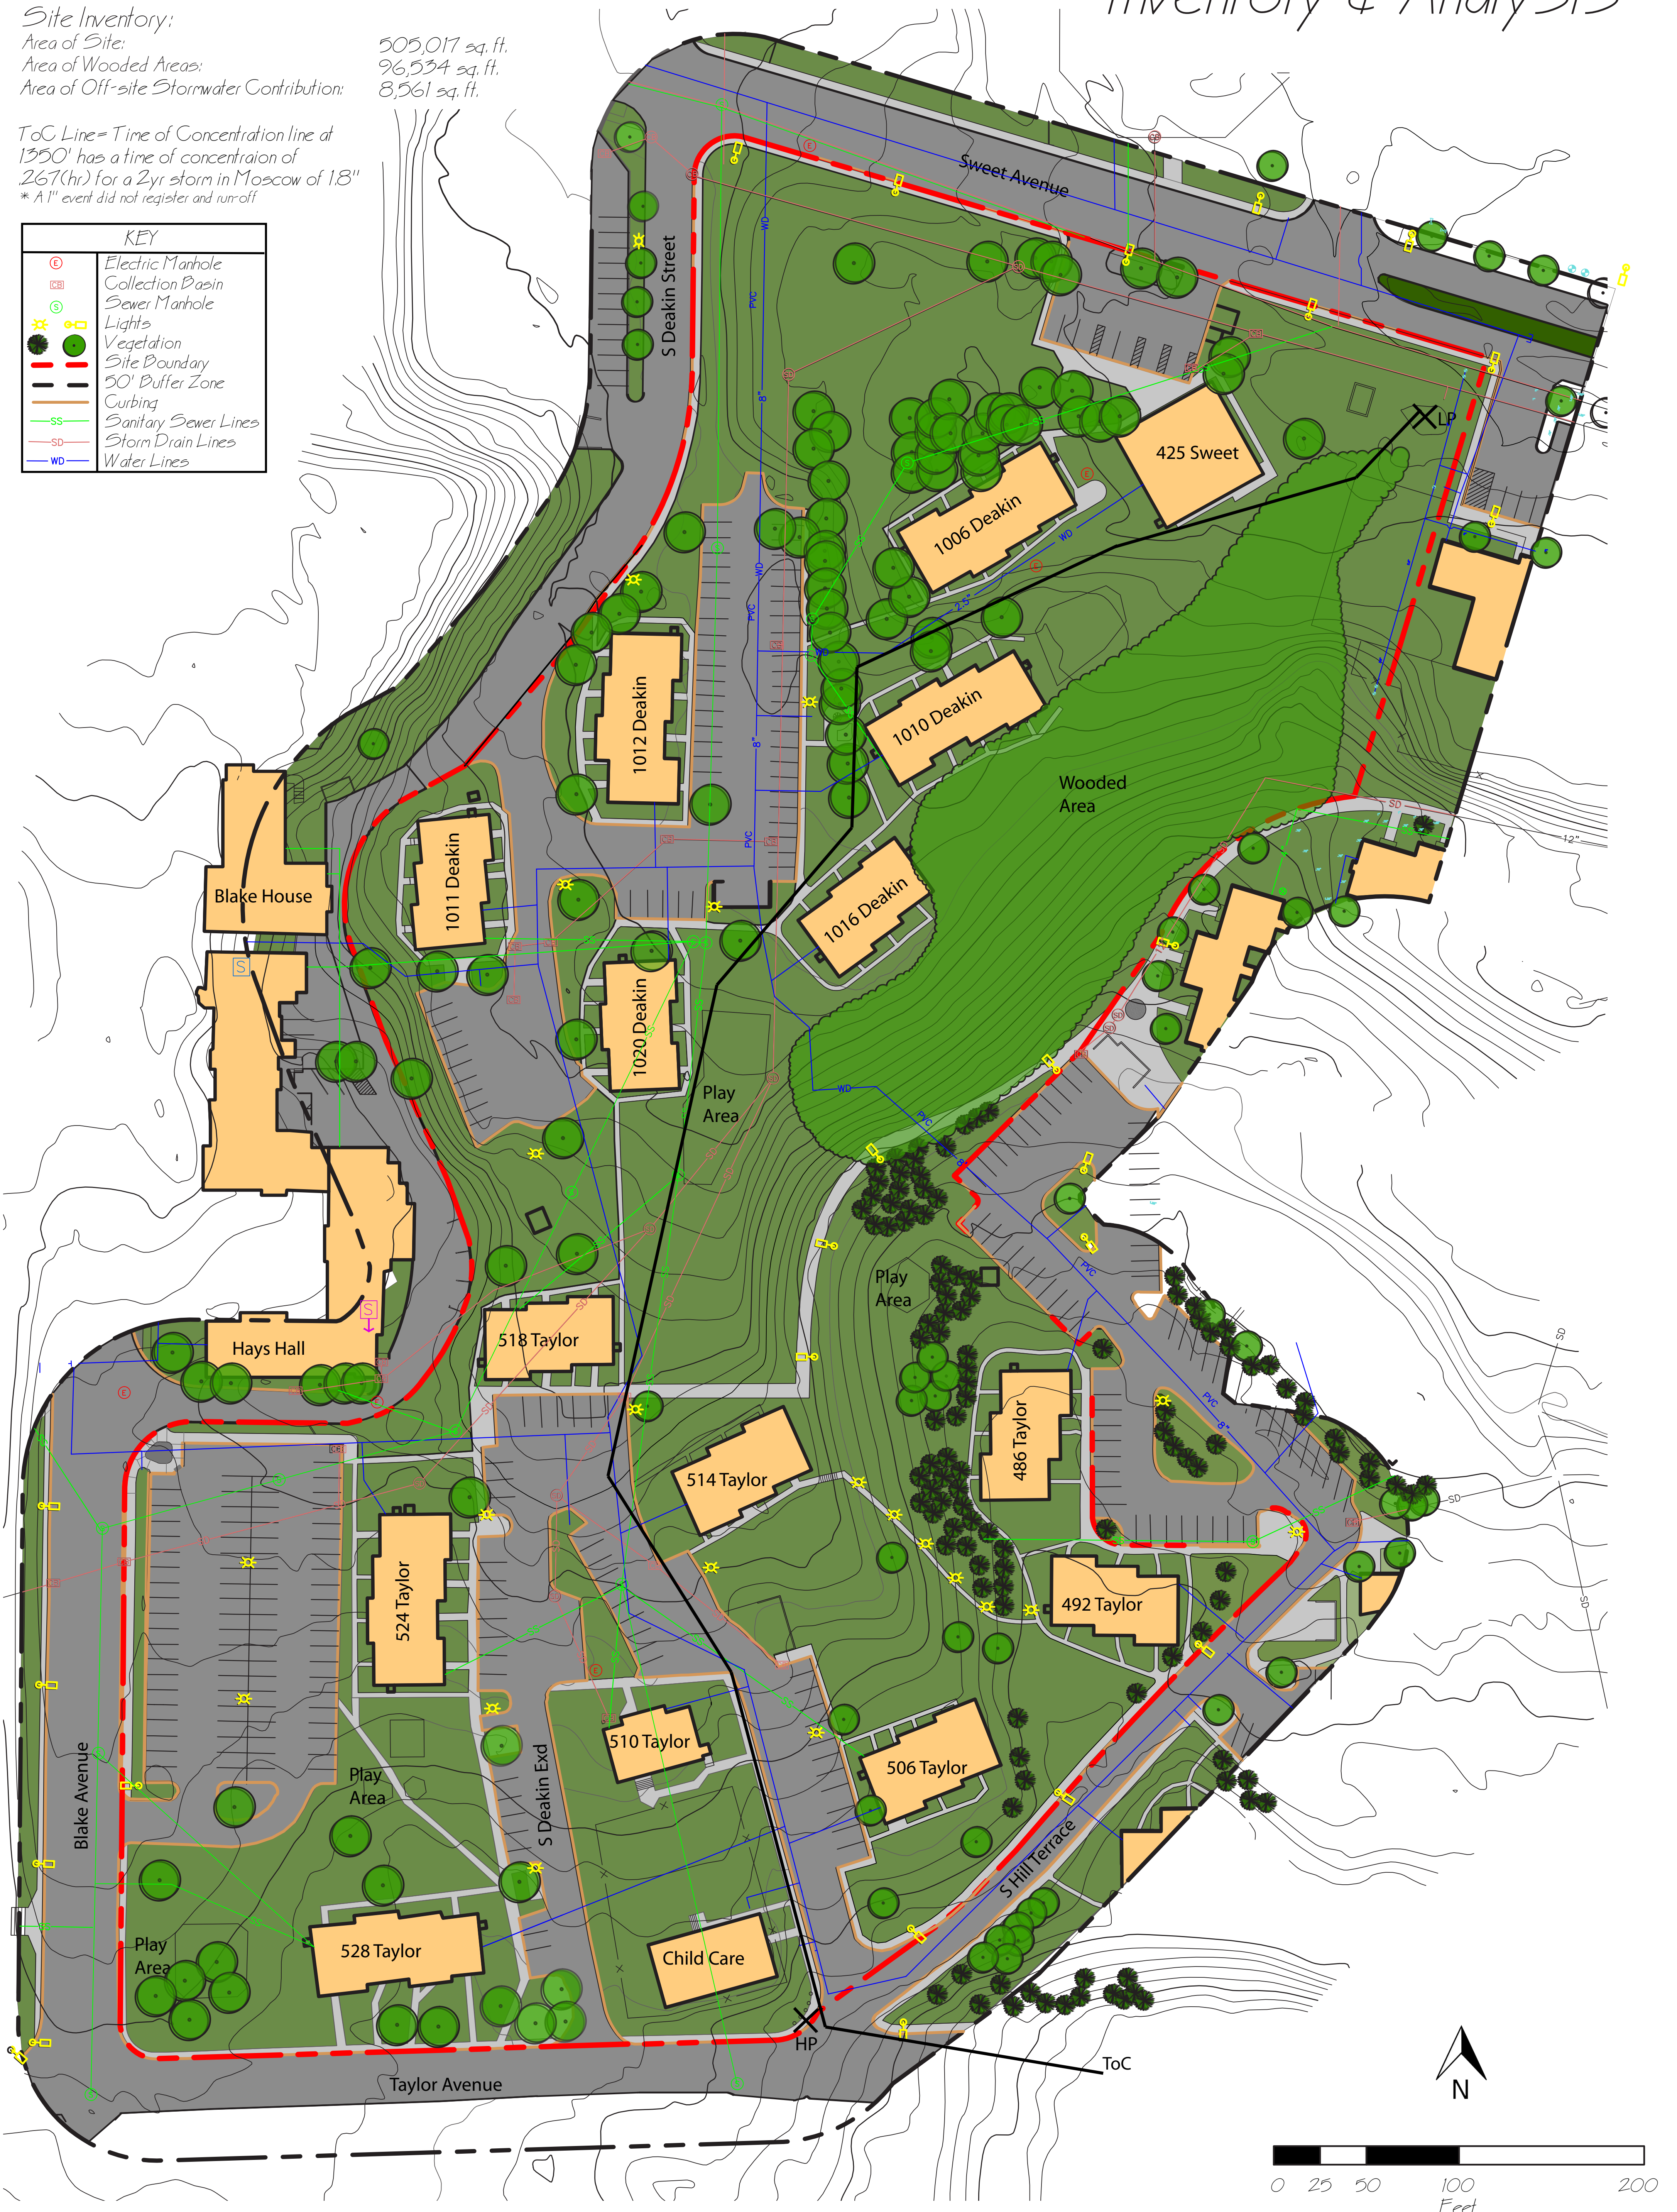
### Site Inventory:

Area of Site: 505,017 sq. ft.  
 Area of Wooded Areas: 96,534 sq. ft.  
 Area of Off-site Stormwater Contribution: 8,561 sq. ft.

ToC Line = Time of Concentration line at 1350' has a time of concentration of 2.67(hr) for a 2yr storm in Moscow of 1.8"  
 \* A 1" event did not register and run off

KEY	
(E)	Electric Manhole
(CB)	Collection Basin
(S)	Sewer Manhole
(*)	Lights
(T)	Vegetation
(-)	Site Boundary
(-)	50' Buffer Zone
(-)	Curbing
(SS)	Sanitary Sewer Lines
(SD)	Storm Drain Lines
(WD)	Water Lines

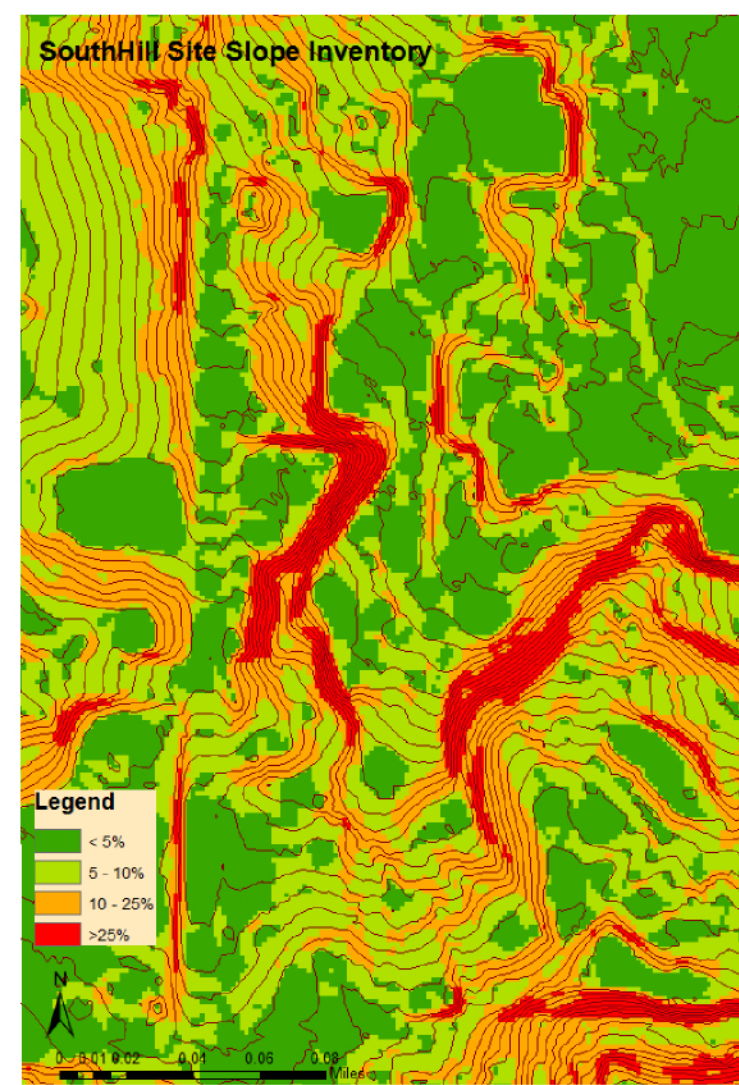
## Slope Inventory:

As with the climate, there is a wide variety of slopes the site. Ranging from nearly flat, to greater than 25%. Some of the steepest slopes on site are heavily vegetated with trees and grass. The majority of slopes on the site are less than 10%.

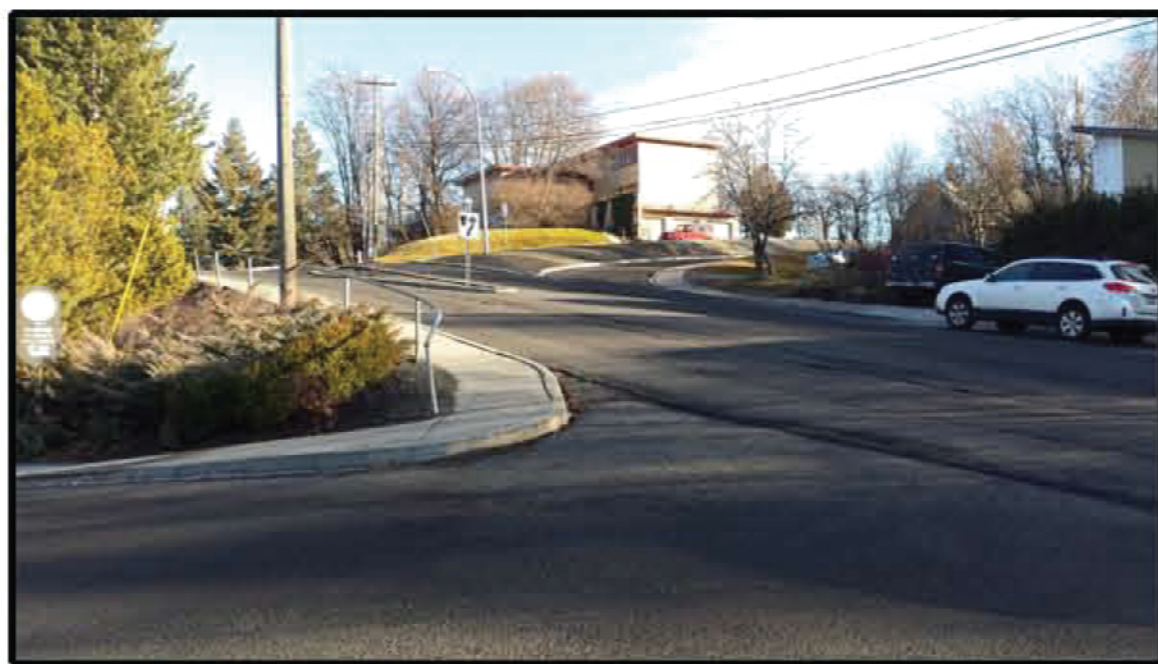
1. Taylor Ave Entry - All water from street flows right onto site

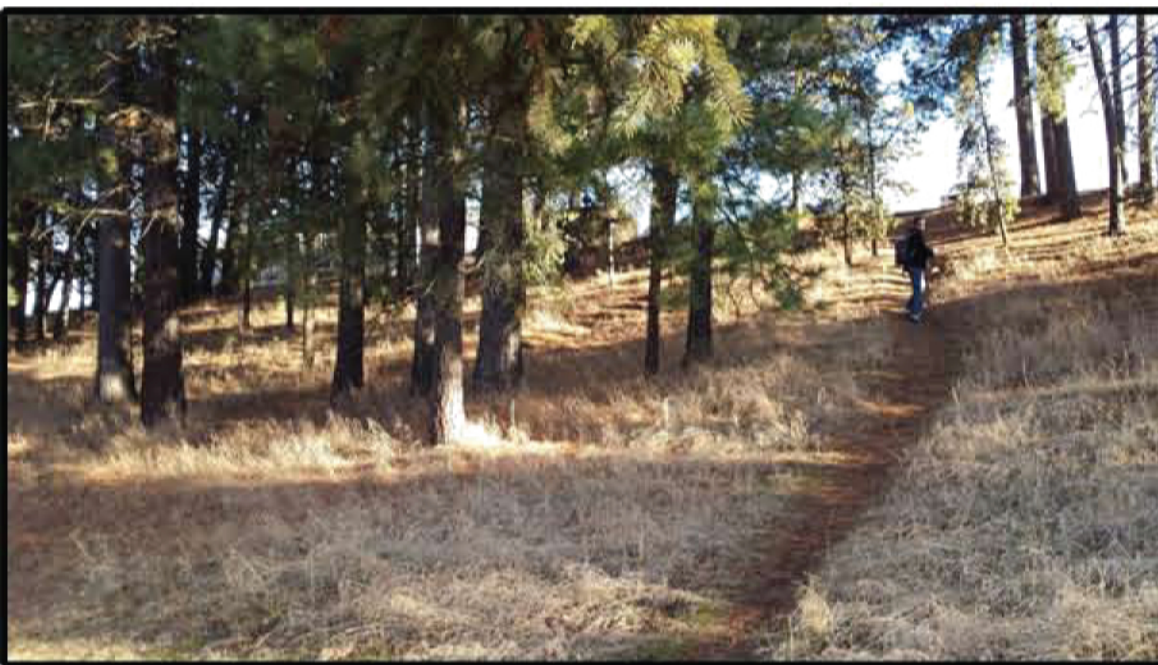
2. Large stand of Pines on the site is in excellent condition, some treatment for the brush is needed. Paths of desire have been clearly laid to the current design and could use professional attention for safety and aesthetics.

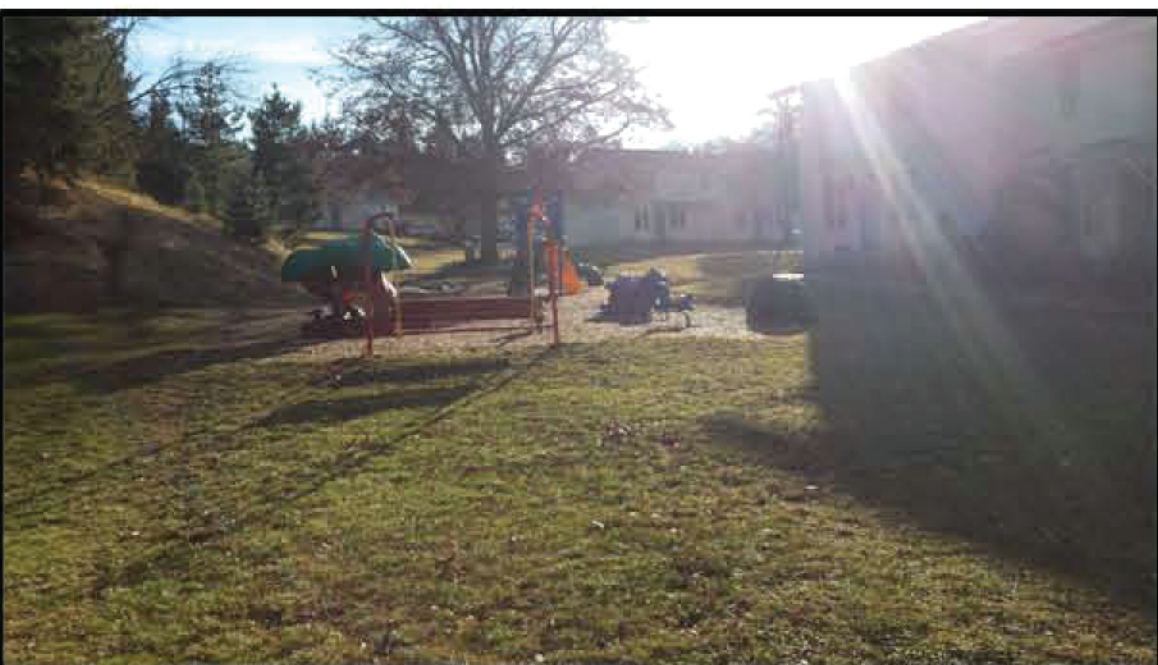
3. Playground has no sense of place and lacks nearly any appeal to encourage play. The area is close to the apartments, however there is difficulty seeing children playing from the apartments. There is good sun light and mild slope.

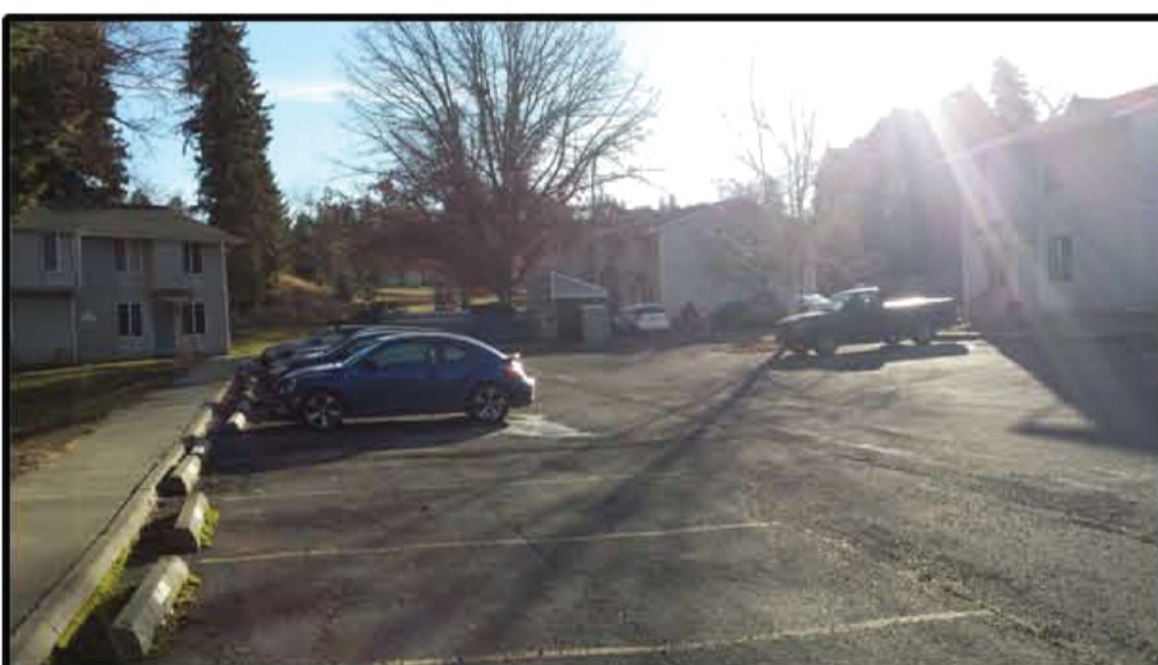
4. Parking lot with great potential to be a center of the housing area. Very gentle slopes and receives a significant amount of sunlight year round. There is also a wooded area on both side of the lot.

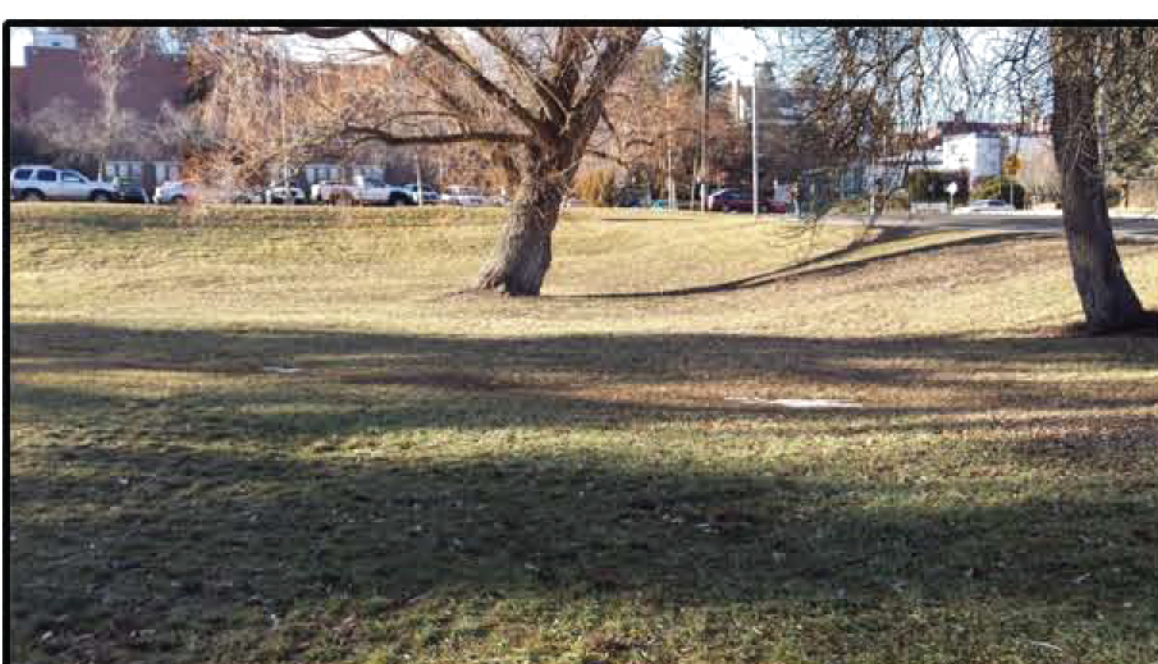
5. Corner of Sweet and Deakin. Large old Willow. Large vacant area is in need of gathering amenities. Great opportunities for landscape rec area.

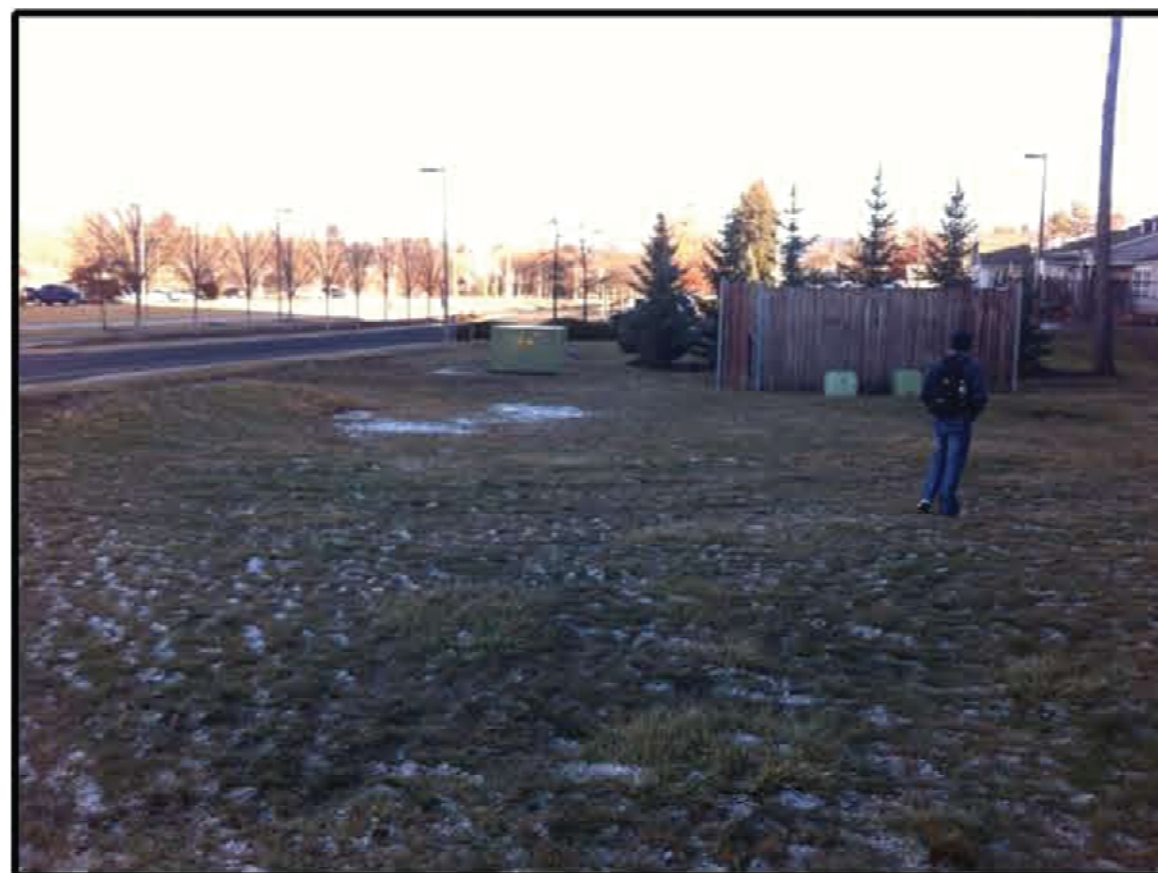
6. Transformers at the low point on the site. This is a prime are for gathering because of its location on Sweet Ave.

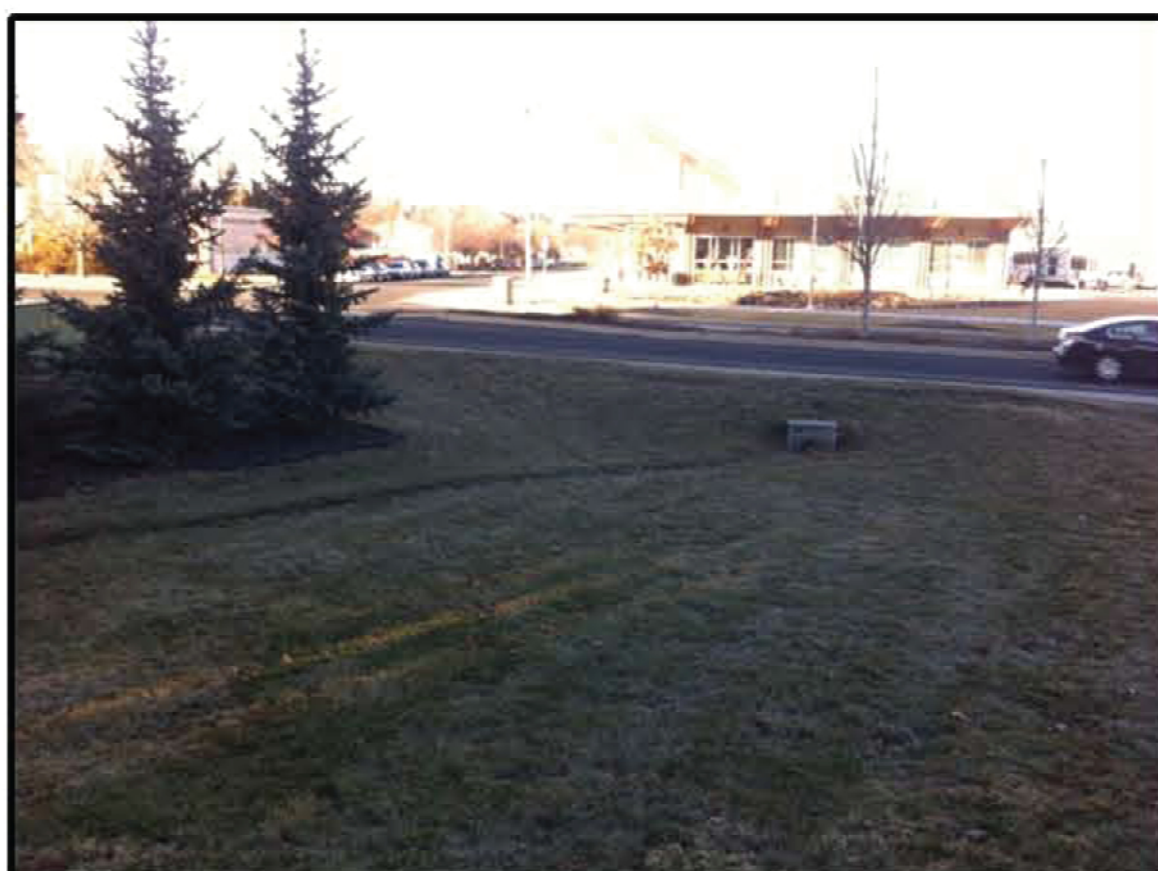
7. The low point on the site with a drain the brings water under sweet Ave.

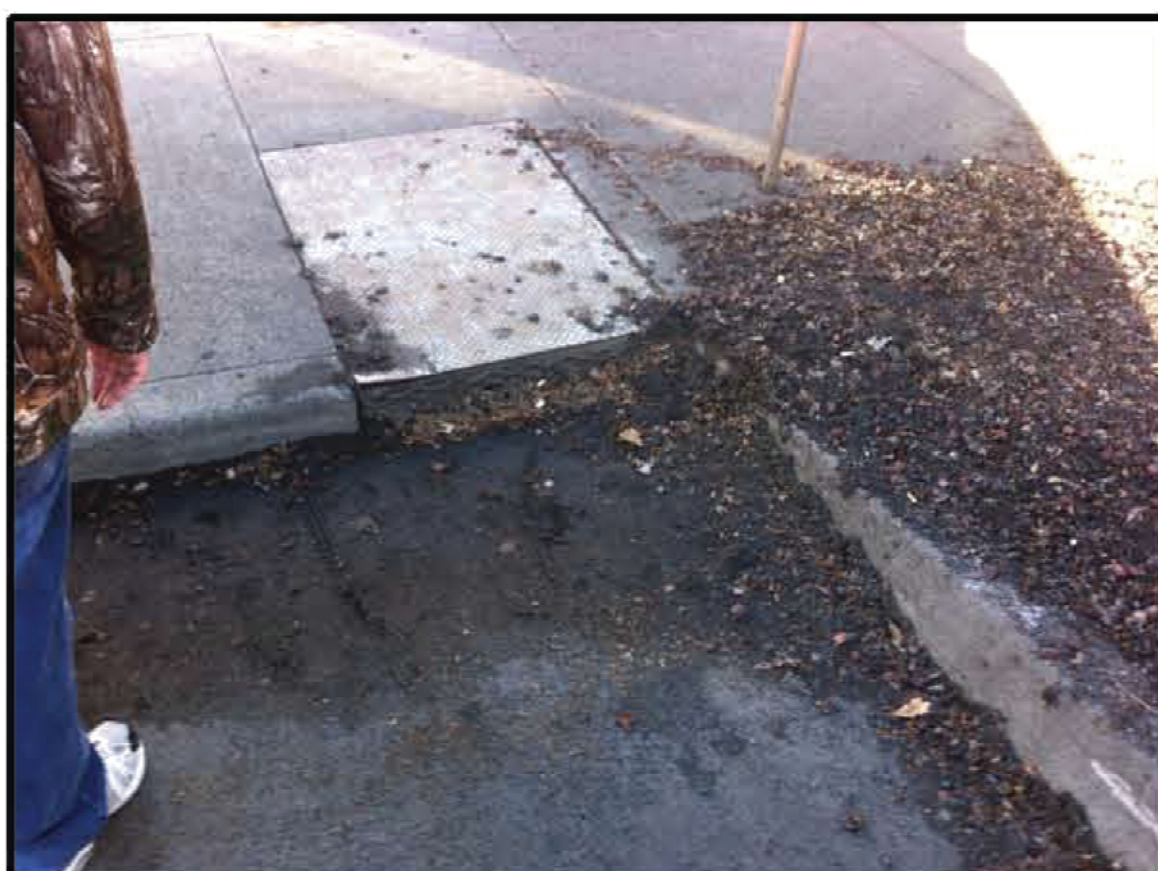
8. Drain to help water escape the parking lot during storm events. Clearly clogged and poorly managed.

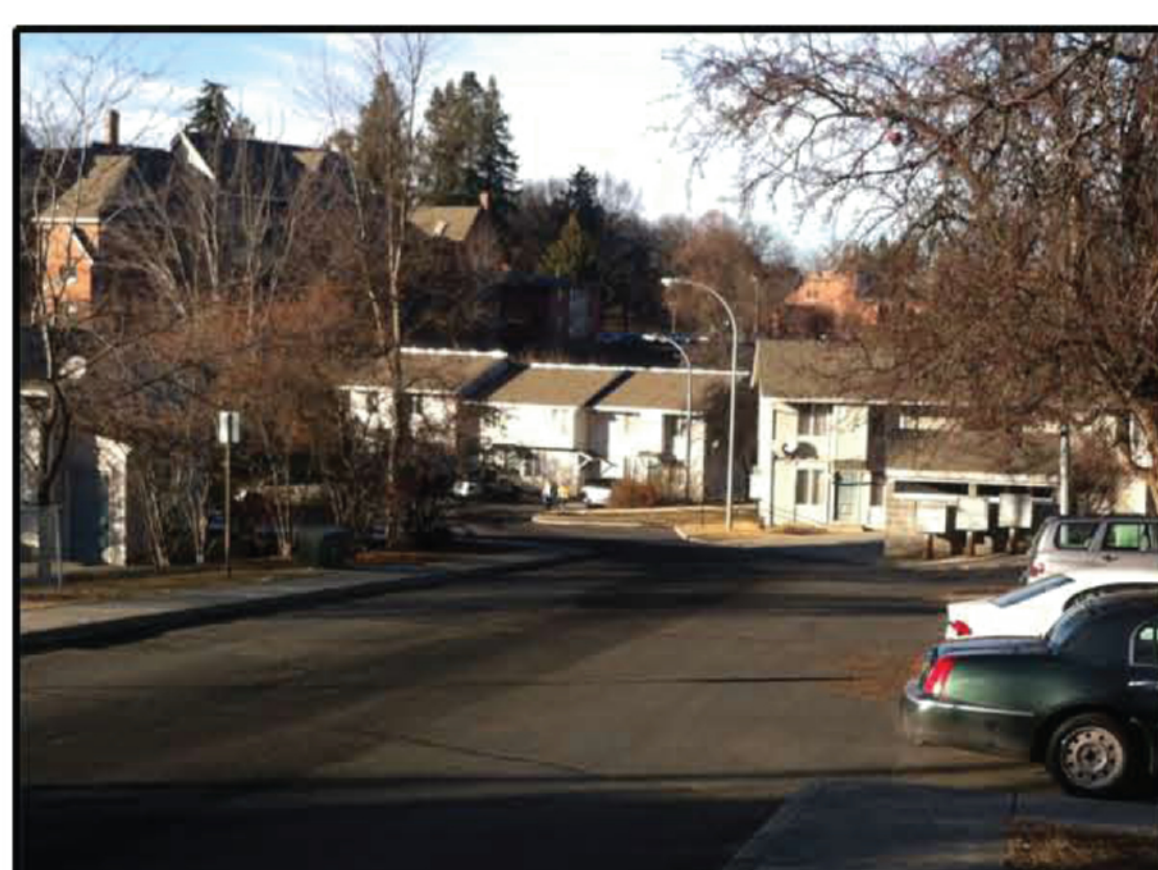
9. Looking in from Taylor Ave. Water flows directly towards buildings, bypassing drains because of poor placement.

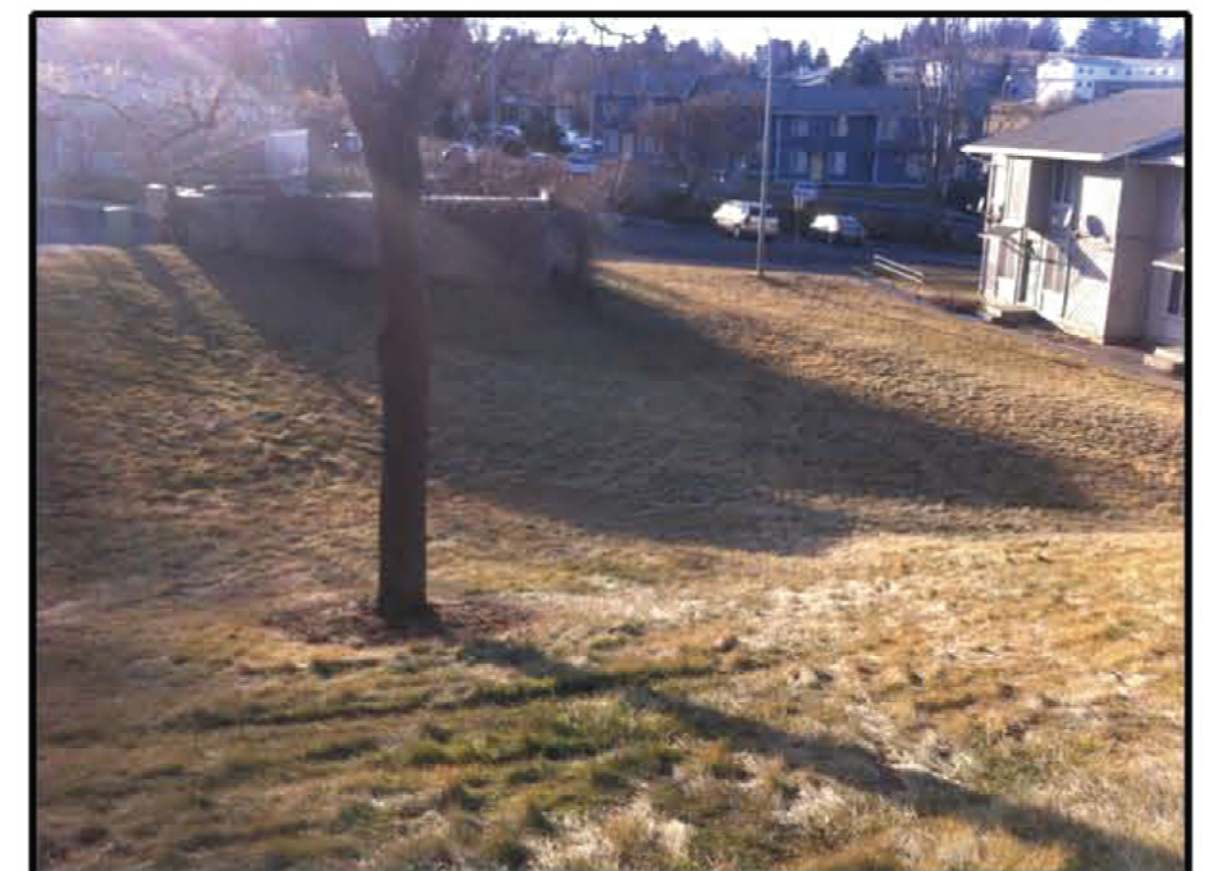
10. Entire grassy area drains to door step of apartments. Large wasted grassy space.

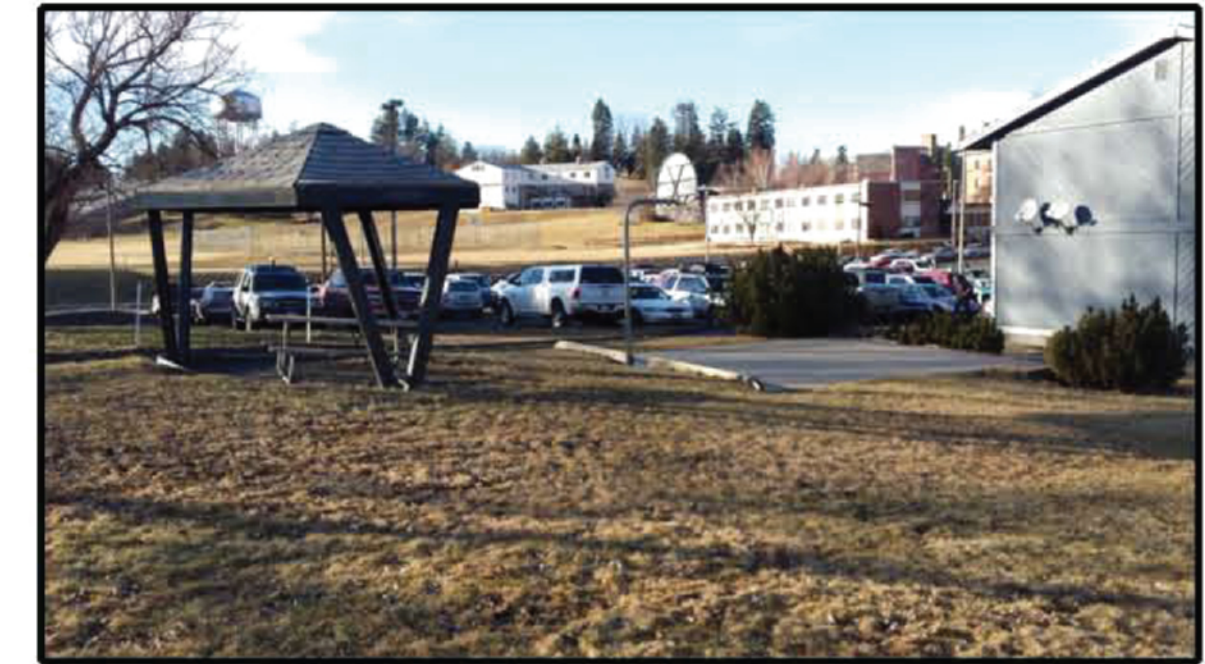
11. Small gazebo and basketball court. Not very inviting.
