## **Brooklyn Bridge Park: Pier 1 and Pier 3-4 Uplands Methods Document**

## Overview of Research Team Strategy

Brooklyn Bridge Park (BBP) is a large and complex constructed landscape, parts of which remain under construction at the time of this case study's publication, and which upon completion will eventually occupy 85 acres along the Brooklyn, NY waterfront. The park repurposes piers 1-6 of the former industrial owner, the Port Authority of New York and New Jersey, and retains the pier names from the prior industrial use. For the purposes of this LAF case study, the research team focused its attention solely on Pier 1 and Pier 3-4 Uplands (13.6 acres), an area outlined below in Figure 1.

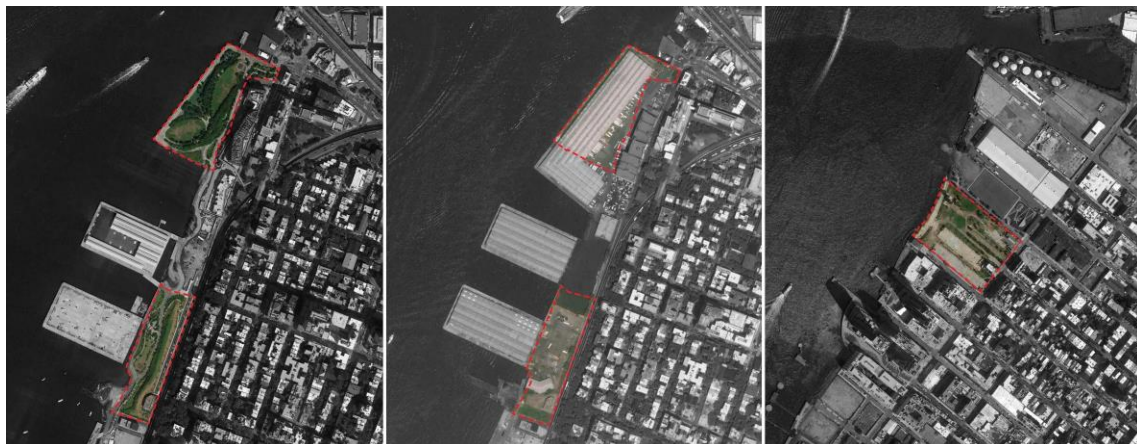
Figure 1. Comparison of Brooklyn Bridge Park Study Area (left) and equivalent "traditional" park (right). (Source: GoogleEarth)

Left: BBP Study Area, 2016

Center: Pre-existing Condition, 2008

Right: East River State Park

For the nearby "traditional" reference landscape, we identified East River State Park as an appropriate comparison site, because of its rough equivalency in terms of:

- size (6.99 acres for East River State Park vs. 7.64 acres for Pier 1 and 5.97 acres for Pier 3-4 Uplands),
- waterfront location (also on the East River and also in Brooklyn),
- proximity (2 miles away),
- age (9 years since construction for East River State Park vs. 6 years for BBP Pier 1).

Primarily composed of lawn, trees, and meadow grasses planted on and around the former industrial traces of the Brooklyn Eastern District Terminal. With its simple design, simple palette of landscape elements, East River State Park represents a good example of a typical "traditional" municipal park response to a heavily used post-industrial waterfront site close to a residential neighborhood--all good analogs for BBP.

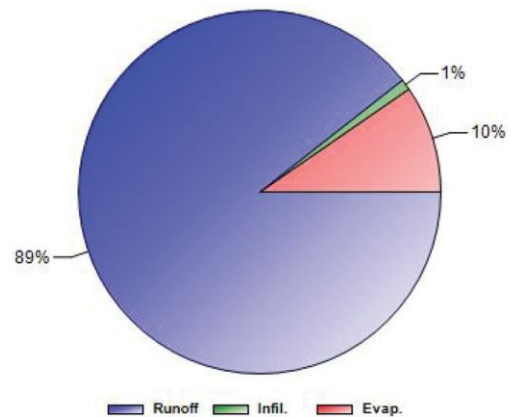
Figure 16. Brooklyn Bridge Park Pier 1 Pre-existing Conditions EPA Stormwater Calculator Results.

Statistic	Current Scenario
Average Annual Rainfall (inches)	59.89
Average Annual Runoff (inches)	53.72
Days per Year With Rainfall	81.00
Days per Year with Runoff	71.00
Percent of Wet Days Retained	12.35
Smallest Rainfall w/ Runoff (inches)	0.12
Largest Rainfall w/o Runoff (inches)	0.18
Max. Rainfall Retained (inches)	0.16

Based on EPA Stormwater Calculator results, Pier 1 current conditions reduce average annual runoff by 81.3% relative to preexisting conditions  $[(53.72-10.04)/53.72]$  and reduce the number of days per year with runoff by 43 (71-28). In comparison to East River State Park, Pier 1 current conditions retain 51.4% more of the local average annual rainfall  $[(40.83-10.04)/59.89]$ .

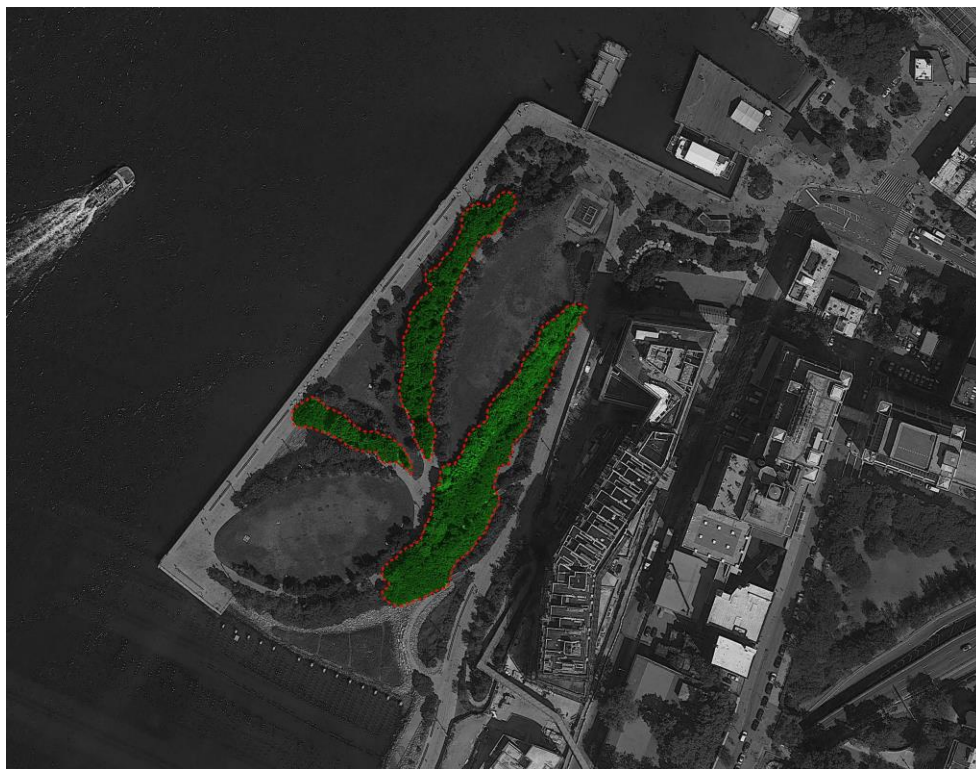
Figure 2. Pier 1 Managed Succession/Dense Hedgerow Areas.

The “managed succession areas” on Pier 1 and Pier 3-4 Uplands at Brooklyn Bridge Park are densely planted zones, denoted as “dense hedgerows” and “managed succession areas” by BBP’s designers. They are characterized by a mixed planting of shade tree species, understory trees and shrubs, and an herbaceous layer. The design intent of these planting areas was for the structure and character of vegetation to change over time due to plant growth, competition and changing microclimatic conditions. This intent has carried through to the ongoing park maintenance. Maintenance staff regularly culls overly dominant plant material, alters understory plant species as the amount of shade in the dense hedgerows gradually increases, and prunes woody plant material such that long-lived shade tree species are given competitive preference over shorter-lived early successional tree species. (While having different nomenclature, “dense hedgerows” and “managed succession areas” appear visually similar and receive identical maintenance routines and practices, and for the purposes of study, these areas will be collectively referred to as “managed succession” areas) (Figure 2).

Floristic Quality Assessment Index metrics were used to compare a portion of the site representative of the “managed succession” conditions as *designed* (Figure 2) to:

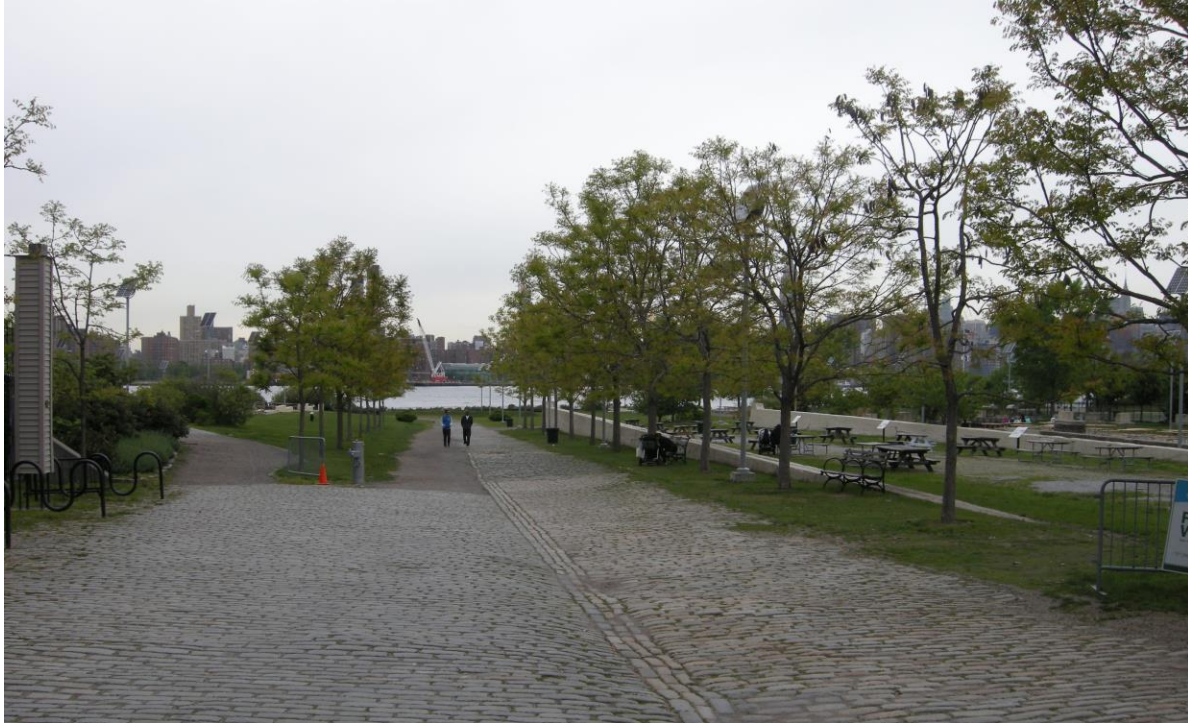
Figure 4. *East River State Park Reference Planting: double row of monocultural shade trees.*  
*Landscape Architecture Foundation (Sean McKay, CSI 2016)*

For the “traditional” park reference site, the managed succession FQI at BBP was compared to the most similar planting typology found at East River State Park. Since the managed succession areas at BBP are typically located along paths with the primary design intent of structuring spaces and framing views<sup>10</sup>, the closest equivalent use at East River State Park is a double row of monocultural shade trees planted along the main entry path (Figure 4). The vegetation at East River State Park was inventoried on-site by the research team and utilized for the vegetative comparisons found within this document.

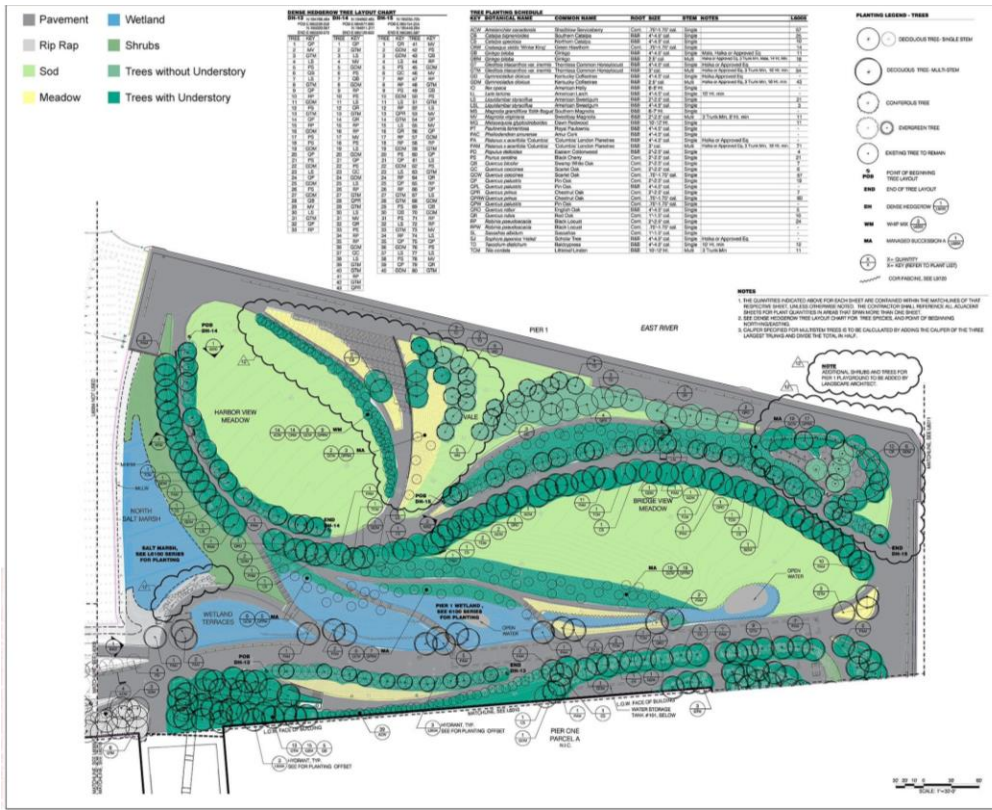
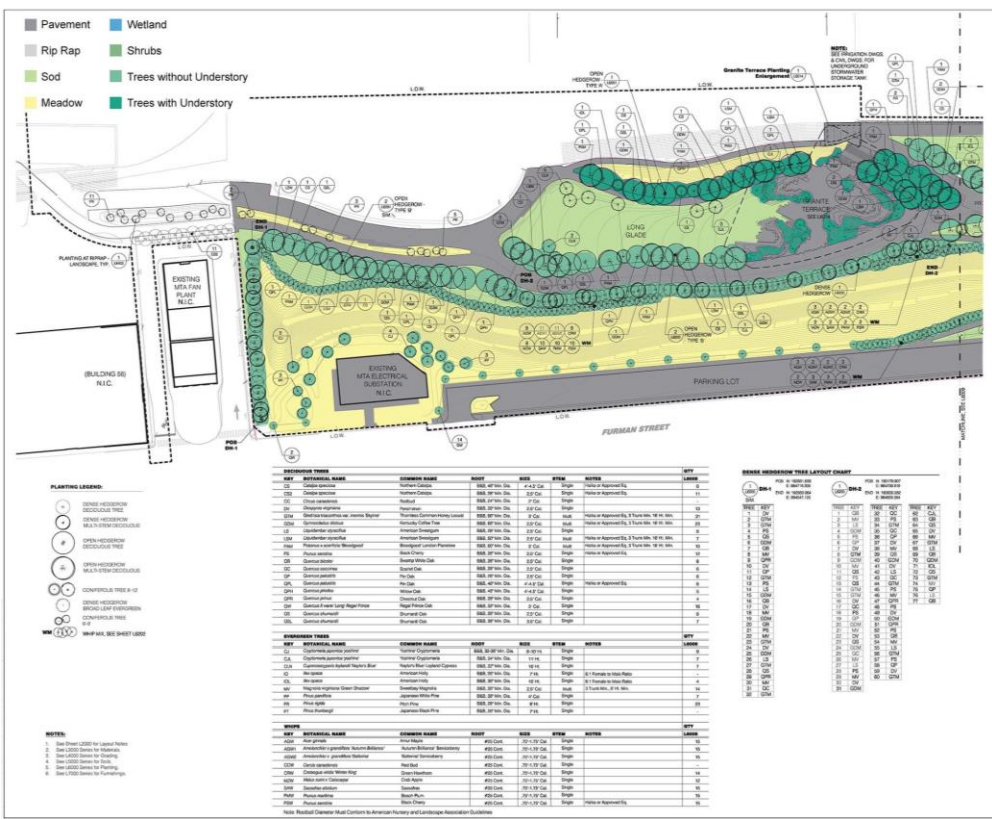
Figure 8. Brooklyn Bridge Park Design Conditions BDI.

The BDI was calculated for 1) the pre-existing landscape condition and 2) the designed landscape condition for Pier 1 and Pier 3-4 Uplands, as well as 3) the traditional reference waterfront park landscape at East River State Park. BDI was calculated in accordance with the methodology outlined by SITES credit 4.6: *Preserve or Restore Appropriate Plant Biomass on Site*. Area takeoffs for each of the 3 calculations were based on the following, respectively:

**Limitations:** BDI was based on general area of the planting indicated on the landscape plan. On-site observation revealed that species, quantity and location of vegetation has shifted relative to landscape plans provided by MVVA. Such shifts include differing tree species and locations due to tree mortality, relocated and replaced material, maintenance practices and appearance and propagation of introduced tree, shrub and perennial species. Given the coarse categorization of vegetation and reliance on area takeoffs for the calculations, it is unlikely that these shifts would have had a significant impact on the BDI calculations.

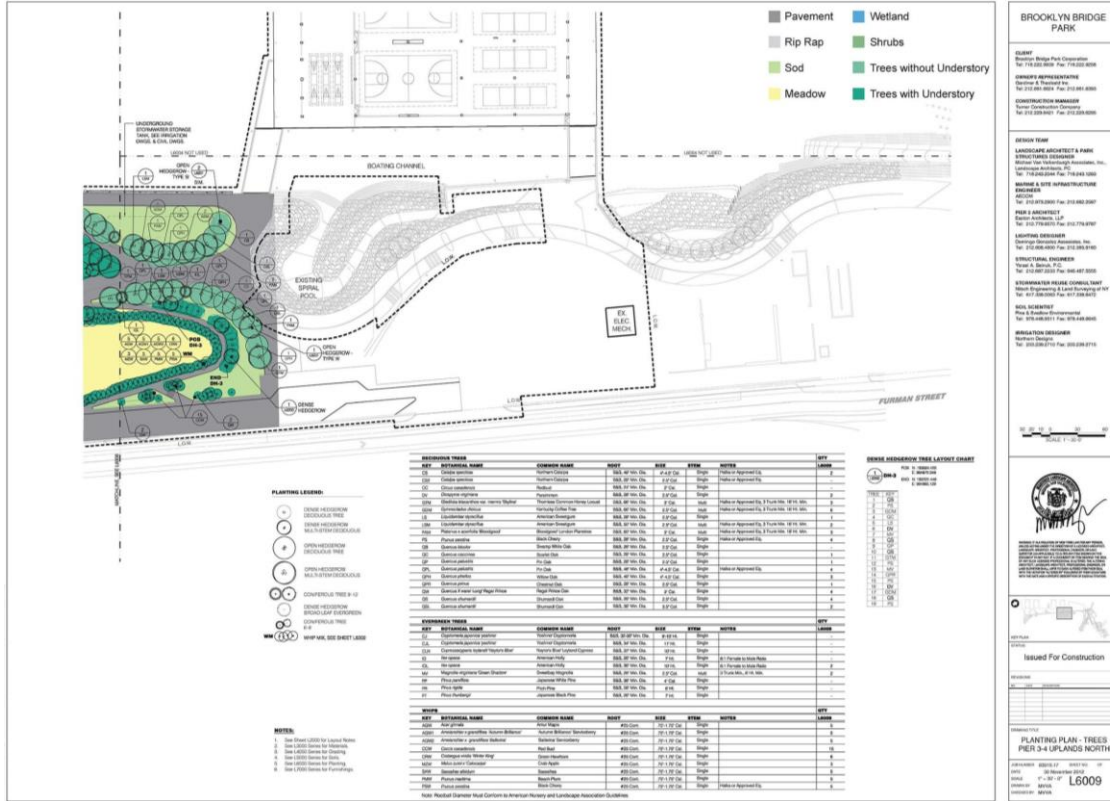
**Brooklyn Bridge Park Pier 1 + 2/3 upland BDI**

Land Cover/vegetation type zones	Biomass density index for this zone	Area (sq. ft.)	Percent of total site area for this zone	Biomass density value x % of total site area
Trees w/understory	6	112282.21	17.95	1.08
Trees w/out understory	4	59420.84	9.50	0.38
Shrubs	3	9161.61	1.46	0.04
Annual plantings	1.5	0.00	0.00	0.00
Grasslands and turfgrass	2	198541.05	31.73	0.63
Wetlands	6	30478.44	4.87	0.29
Impervious cover	0	215758.77	34.49	0.00

**Total BDI 2.43**

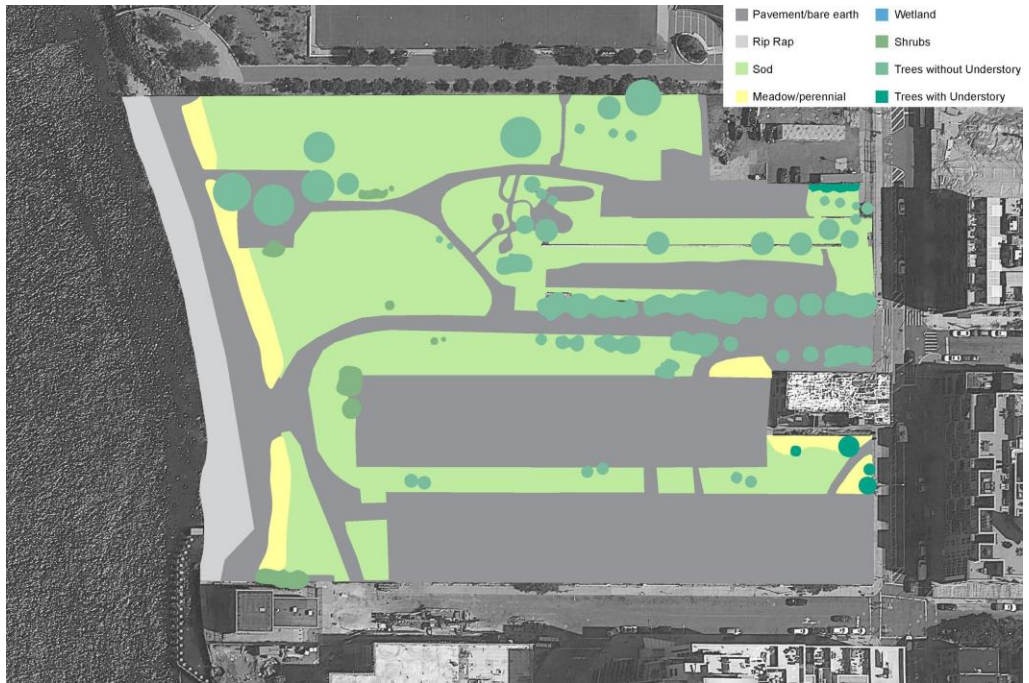
**East River State Park BDI**

Land Cover/vegetation type zones	Biomass density index for this zone	Area (sq. ft.)	Percent of total site area for this zone	Biomass density value x % of total site area
Trees w/understory	6	1044.54	0.26	0.02
Trees w/out understory	4	20048.68	5.04	0.20
Shrubs	3	2210.69	0.56	0.02
Annual plantings	1.5	0.00	0.00	0.00
Grasslands and turfgrass	2	119961.12	30.17	0.60
Wetlands	6	0.00	0.00	0.00
Impervious cover	0	254312.01	63.97	0.00
			<b>Total BDI</b>	<b>0.84</b>

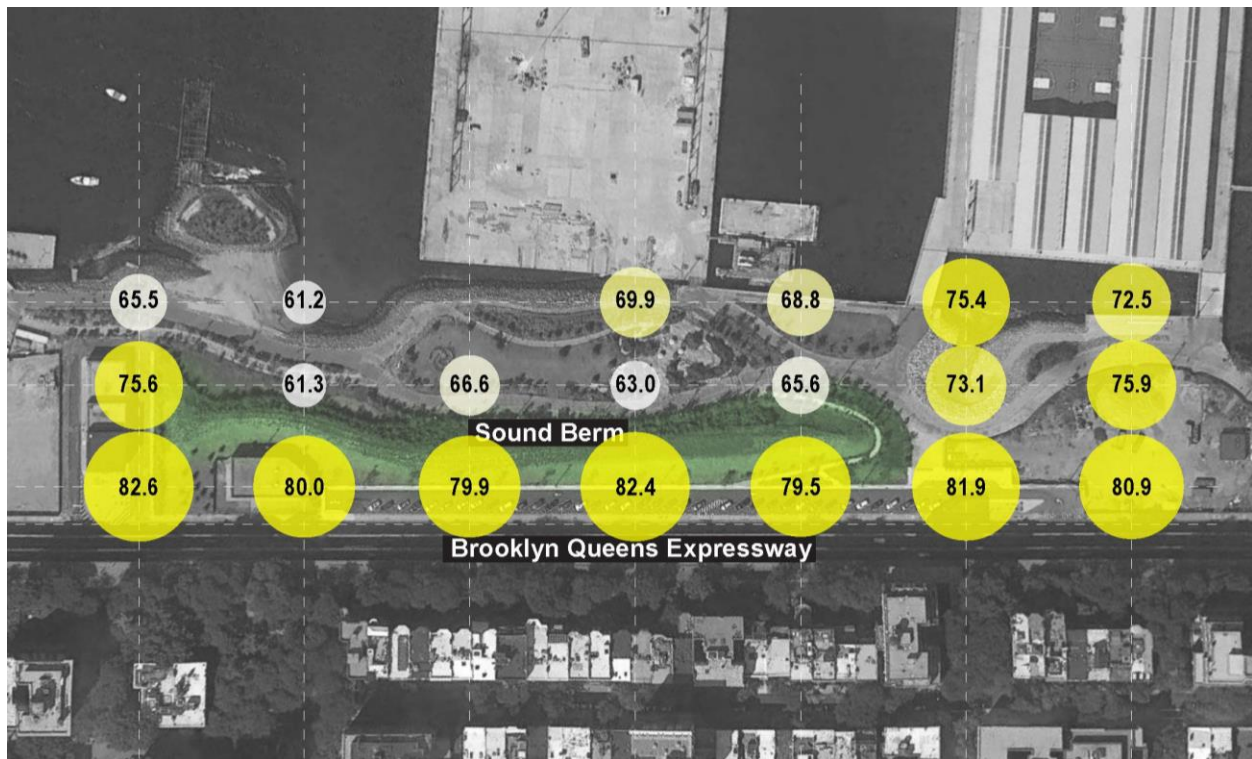
Figure 22. Freely flowing traffic noise levels

The average dB reading at each sample point during free flowing traffic periods (Figure 22) and rush hour traffic (Figure 23) are presented below. Rush-hour traffic moves more slowly than freely flowing traffic, and is typically quieter because tire-pavement noise and engine/exhaust noise of traffic increases with speed. The research team also found that the sound measurement of freely flowing traffic was much more consistent over time, as it was not subject to random starts and stops.

xx.x Avg. dB over 30 sec. sample period

The research team also calculated the benefit at the water's edge by comparing the logarithmic average of the 3 sampling positions along the waterfront that were behind the sound berm (**67.9dB**, as the average of 61.2 + 69.9 + 68.8), the logarithmic average of the 3 sampling positions along the waterfront where no sound berm was present (**72.7dB**, as the average of 65.5 + 75.4 + 72.5). The observed noise reduction at the waterfront can thus be said to be a logarithmic average of 4.8dB. The research team believes that the waterfront was considerably louder than the observed levels immediately behind the sound berm because of an array of ambient environmental sounds coming from the river and from Manhattan -- most notably, the sound of lapping waves breaking against the shoreline, the sound of boats and ferries on the river, and the sound of helicopters flying over the river and taking off/landing at the Wall Street heliport in Manhattan -- and not due to traffic noise from the BQE.

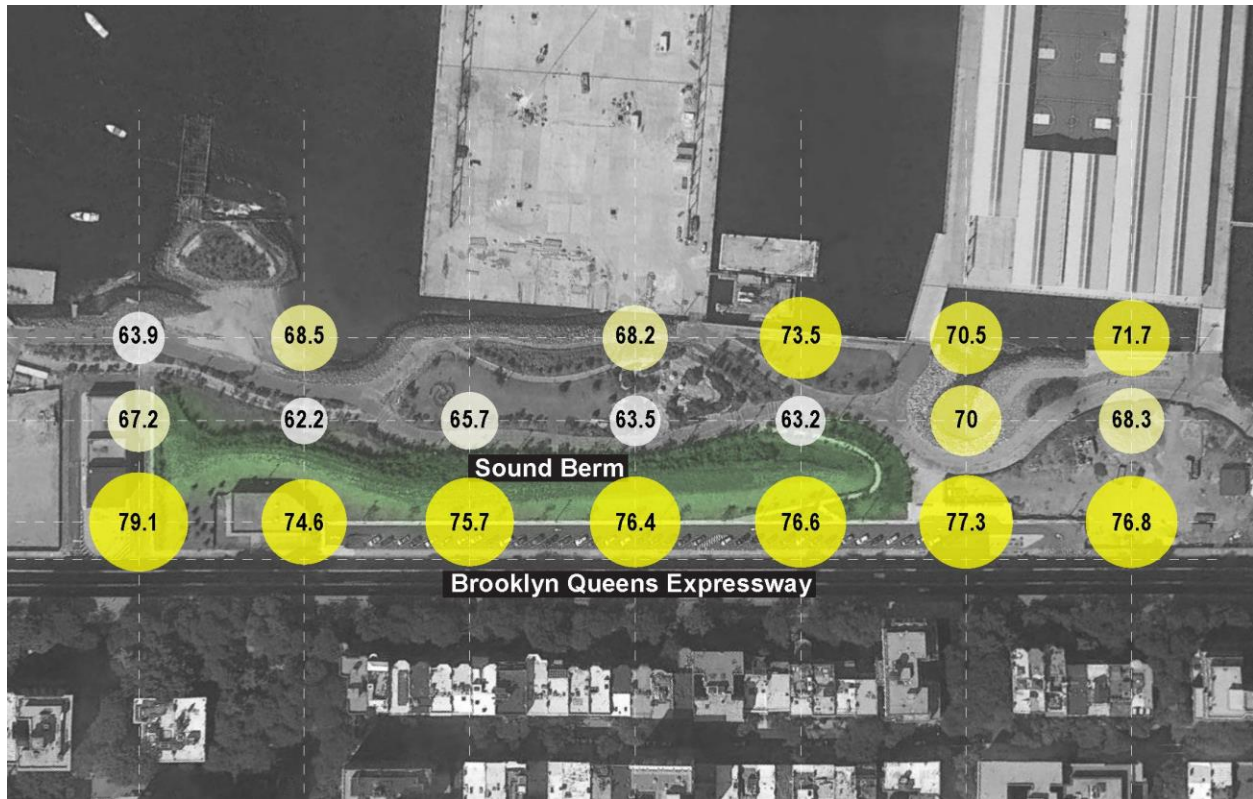
Figure 23. Rush hour traffic noise levels

xx.x Avg. dB over 30 sec. sample period
