NKU Loch Norse Commons

Research Fellow: Christopher Sass Ph.D, ASLA, Assistant Professor, University of Kentucky Research Assistant: Wes Griffith, ASLA, University of Kentucky Firm Liaison: John Carman, RLA, FASLA, Senior Principal, CARMAN August, 2015

This investigation was conducted as part of the Landscape Architecture Foundation's 2015 Case Study Investigation (CSI) program. CSI matches faculty-student research teams with design practitioners to document the benefits of exemplary high-performing landscape projects. Teams develop methods to quantify environmental, economic and social benefits and produce Case Study Briefs for LAF's Landscape Performance Series.

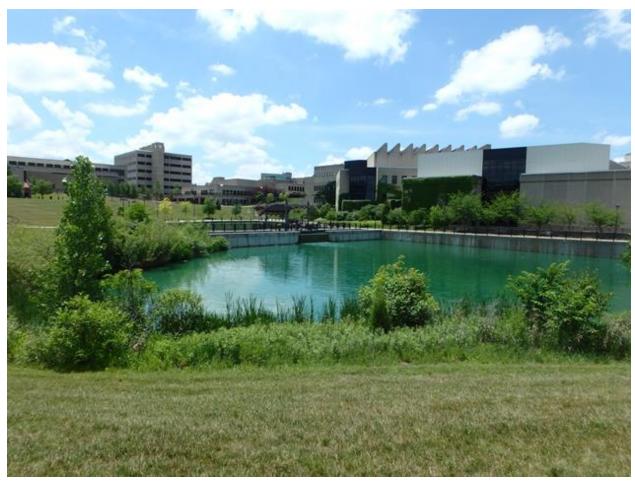
Figure 3. View looking southwest toward Loch Norse and main campus. Native vegetation in foreground (Sass 2015).
