LANDSCAPE PERFORMANCE SERIES

Cornell Plantations Brian C. Nevin Welcome Center

Methodology for Landscape Performance Benefits

Case Study Investigation 2014

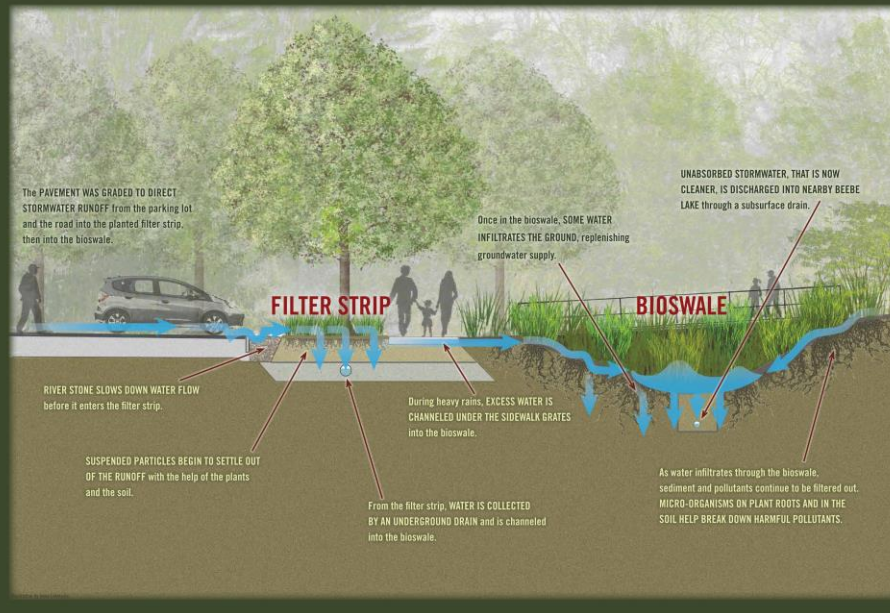
Interpretive Sign, Cornell Plantations

THE LANDSCAPE IN FRONT OF YOU IS DESIGNED TO REMOVE SILT AND POLLUTION FROM SURFACE WATER RUNOFF.

Instead of channeling stormwater from the parking lot into a drainage pipe, the FILTER STRIP and BIOSWALE work together as a "LIVING DRAIN" to capture stormwater, so that it leaves cleaner than when it entered.

Plants in the bioswale are **HARDY, STRONG-ROOTED PERENNIALS AND GRASSES** ABLE TO TOLERATE BOTH WET AND DRY CONDITIONS. Most of them are native to this region.

SWITCHGRASS (*Panicum virgatum*) is a dominant plant in the bioswale. We planted seven cultivars with variations in foliage and flower color.

FLOWERING PERENNIALS, including cultivars of sneezeweed (*Helenium* sp.), Joe Pye weed (*Eupatorium* sp.), and milkweed (*Asclepias* sp.) were planted to provide continuous seasonal interest.

SHRUBS AND SMALL TREES such as winterberry (*Ilex verticillata*), and American hornbeam (*Carpinus caroliniana*) add height and structure to the bioswale.

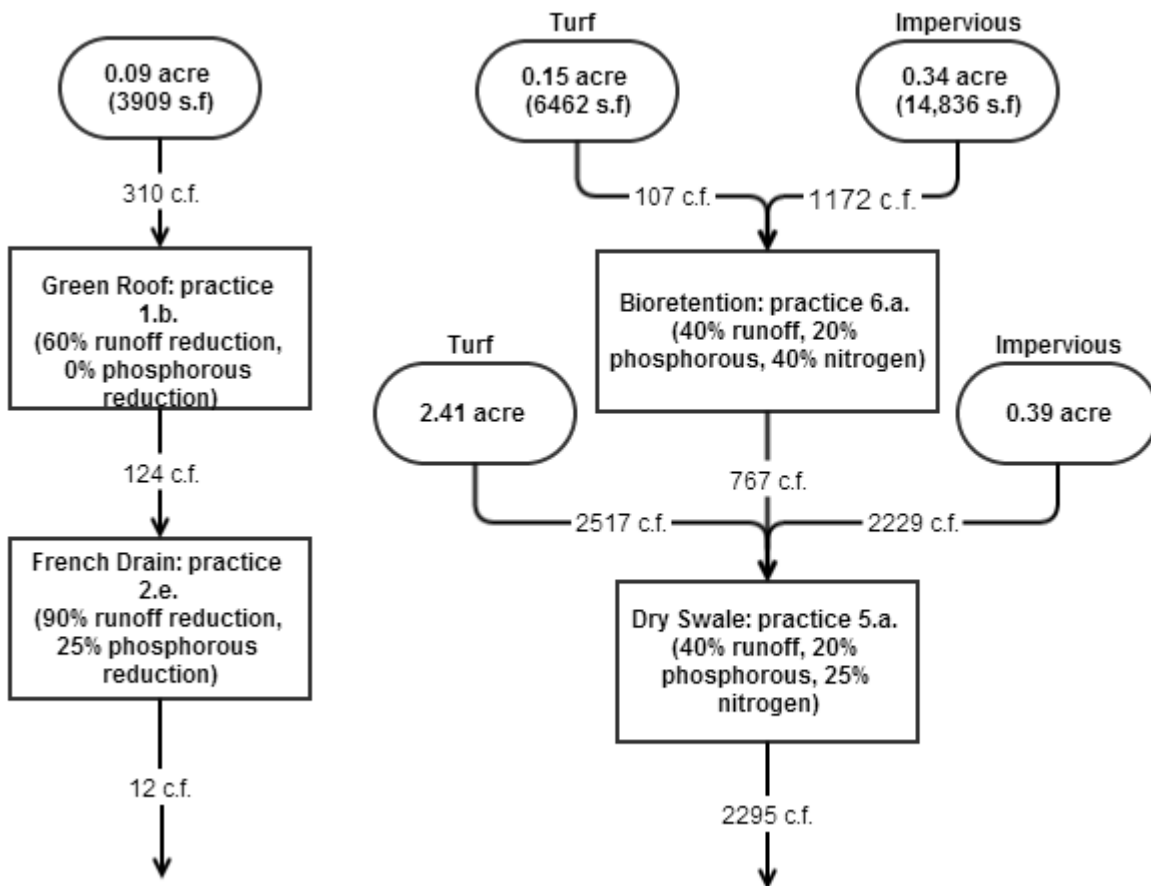
STORMWATER MANAGEMENT SUMMARY

* Values the above boxes summarize the predicted reduction rates for each practice.
