Phipps Conservatory Center for Sustainable Landscapes

Overview of CSI: This investigation was conducted as part of the Landscape Architecture Foundation's 2016 *Case Study Investigation* (CSI) program. CSI matches faculty-student research teams with design practitioners to document the benefits of exemplary high-performing landscape projects. Teams develop methods to quantify environmental, economic and social benefits and produce Case Study Briefs for LAF's *Landscape Performance Series*.

Overview of Research Team Strategy

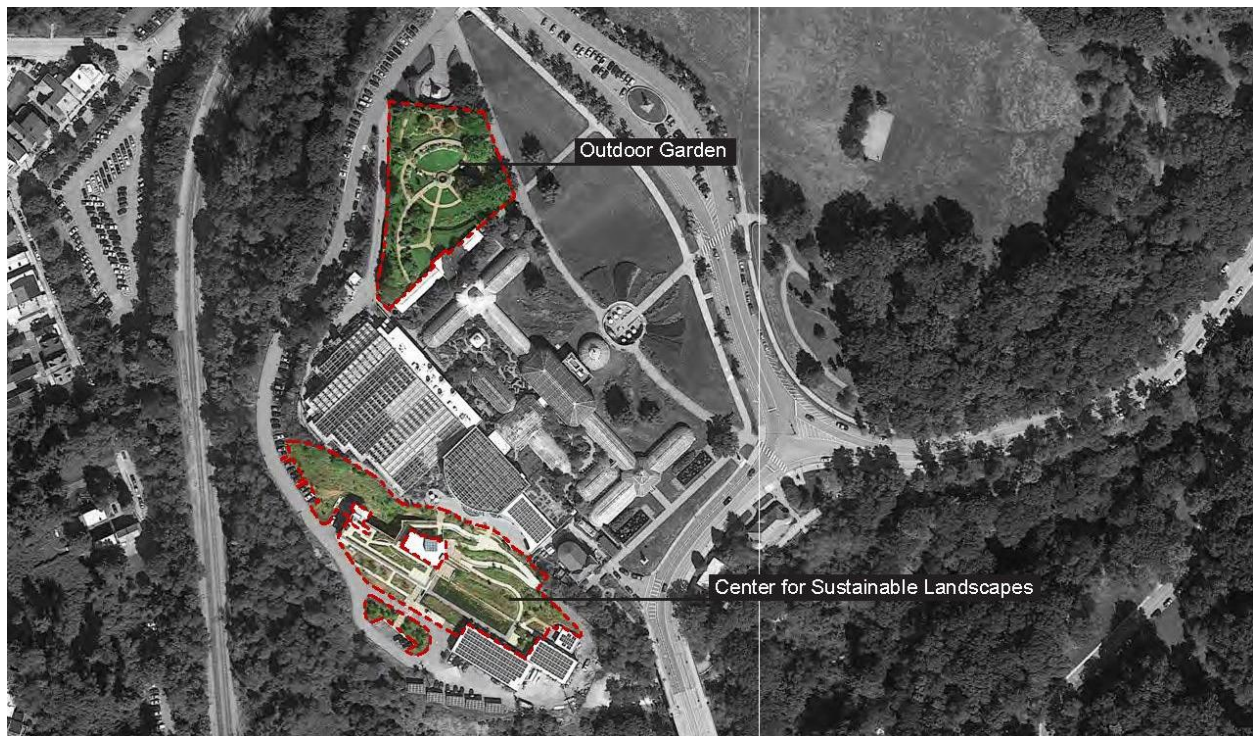
Primarily composed of manicured planting beds with perennial planting and trees, periodic additions of annuals and tropical plants, mowed lawn areas, and pathways, the Outdoor Garden is a good example of a typical "traditional" conservatory outdoor landscape.

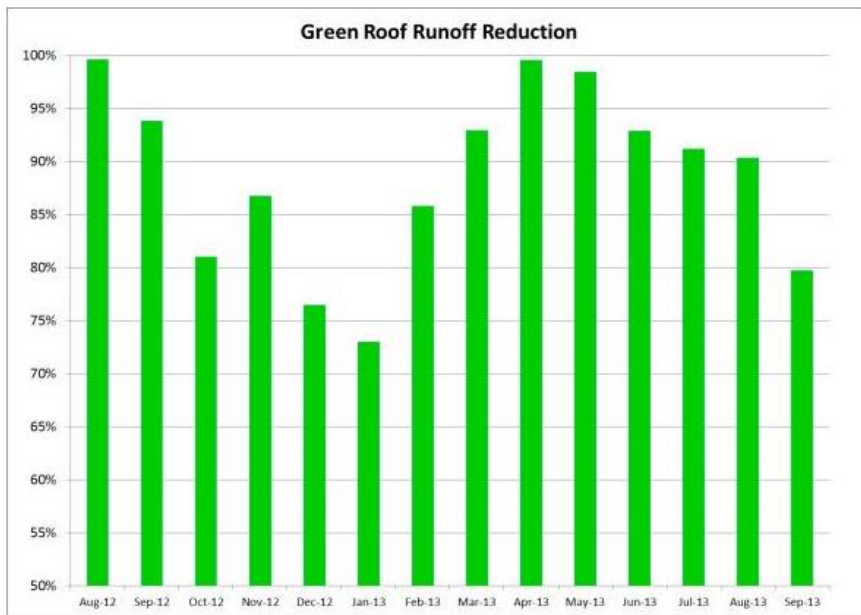
Figure 7. *Green Roof Runoff Reduction. Civil and Environmental Consultants Inc.*

A pan lysimeter is installed on the Center for Sustainable Landscapes 6,050 sf green roof that is used to monitor green roof runoff. Data loggers and sensors collect data every 5 minutes and the data is tracked and analyzed by Civil & Environmental Consultants, Inc. Measured runoff data from the pan lysimeter is compared to total roof rainfall to determine the percentage of runoff reduction. This data and analysis was shared with the research team by Civil and Environmental Consulting Inc (Figure 7).

Assume 100% runoff on a traditional roof.

Average runoff rate for 1-year monitoring data was computed at 87%

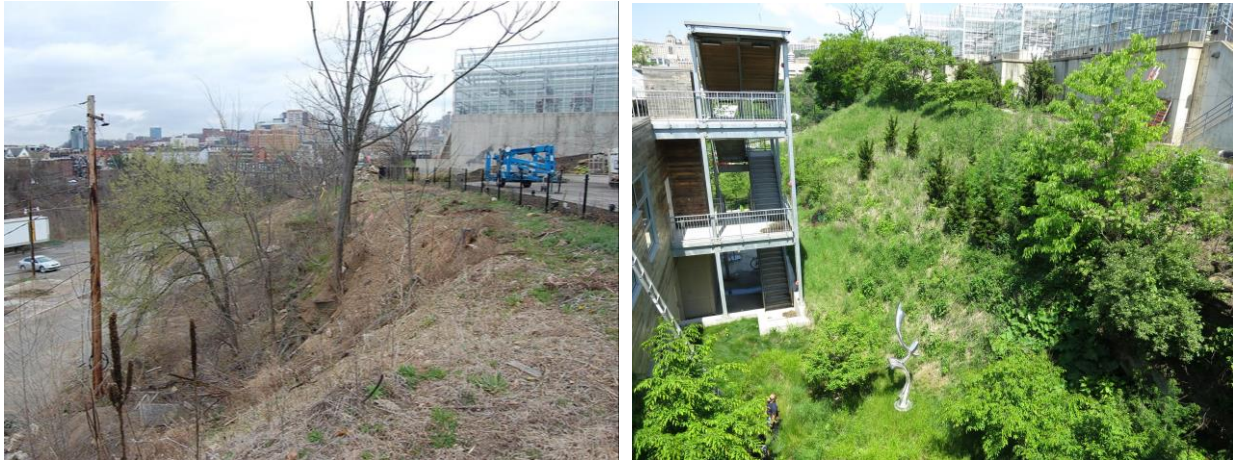
Figure 1. *Pre-existing conditions.* (Andropogon Associates) *Current conditions.* (Nicholas Pevzner, CSI 2016)

The vegetated areas of the pre-existing site primarily consisted of areas of steep slopes, including vertical exposed rock faces that were unmanaged and vegetated by volunteer plant communities (Figure 1). The Center for Sustainable Landscapes design removed existing on-site vegetation, amended and filled steep slope areas with an engineered fiber-reinforced soil mix and seeded with a native seed mix, along with some tree planting. Planting areas along main pedestrian paths within the CSL grounds receive ongoing weeding and maintenance, while the back-of-house steep slope areas at the northwest of the CSL grounds have remained unmanaged since construction. For this environmental benefit, the research team looked at the extent to which Floristic Quality has increased compared to pre-existing site conditions.

Floristic Quality Assessment Index metrics were used to compare 1) the pre-existing and 2) current conditions at the CSL grounds. The study area is outlined in Figure 2 below.

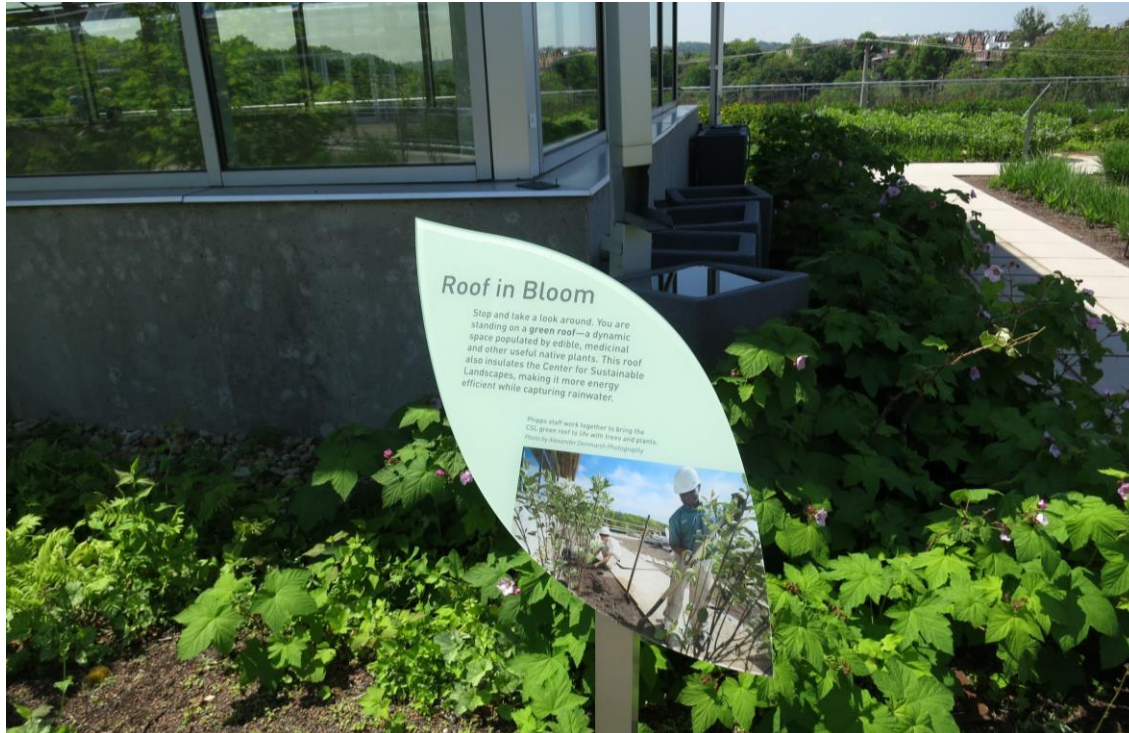
Figure 8. Example of on-site educational signage. Landscape Architecture Foundation (Sean McKay, CSI 2016)

Text for interpretive signage was also supplied to the research team by Dr. Kalnicky. Interpretive signage highlights specific features of the garden and summarize their performative aspects. Included below is a sample of signage text and of signage installed on site:

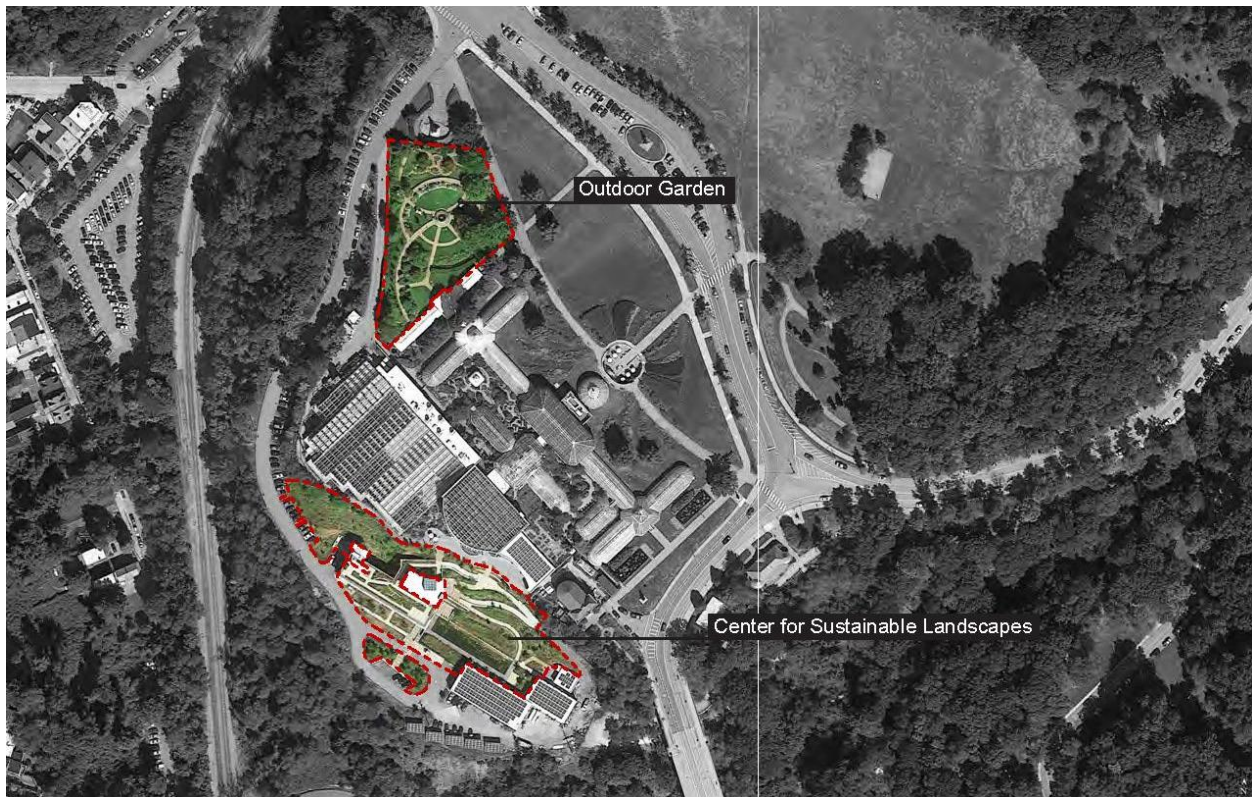
Figure 11. Outdoor Garden and Center For Sustainable Landscapes Maintenance Areas

Although the overall annual maintenance costs are higher for the Center for Sustainable Landscapes, the maintenance area is also 18,957 sq. ft. greater in size than the Outdoor Garden. Based on areas the annual maintenance budget is actually \$.21 per sq. ft. lower for the Center for Sustainable Landscapes.
