LANDSCAPE ARCHITECTURE FOUNDATION

U.S. Coast Guard Headquarters at St. Elizabeth's Methods Document

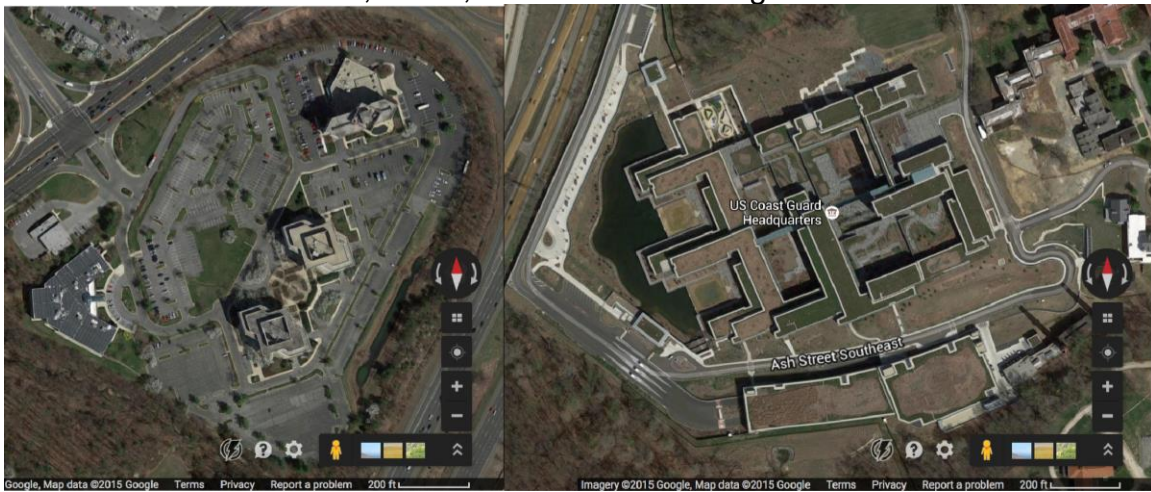
Figure 1 - Comparison of a traditional office complex design and the U.S. Coast Guard headquarters (source: Google Maps)

Left: Traditional Office Site

Right: Coast Guard headquarters

For convenience, some analyses included a comparison with a traditional office park of similar size in the same region (see figure 1) to determine performance against a standard practice or norm. The comparison site was located at 4061 Powder Mill Road in Calverton, Maryland. In addition, a number of direct observations were made on the Coast Guard headquarters site, using the necessary equipment for dependable data results. Finally, a number of professional reports, award applications and construction documents were reviewed to find and quantify the landscape benefits described below. These are sorted into environmental, social, and economic categories.

The U.S. Coast Guard headquarters and a traditional office complex (see figure 1) sites were compared by calculating native woody plant richness. Woody plant species at the traditional office complex were identified and recorded as described in the previous section. To be clear, herbaceous plants were not surveyed at the traditional site. The woody plant species at the U.S. Coast Guard headquarters were derived from the planting plan lists (see figure 4). The native woody richness values and comparison ratio were calculated as follows:

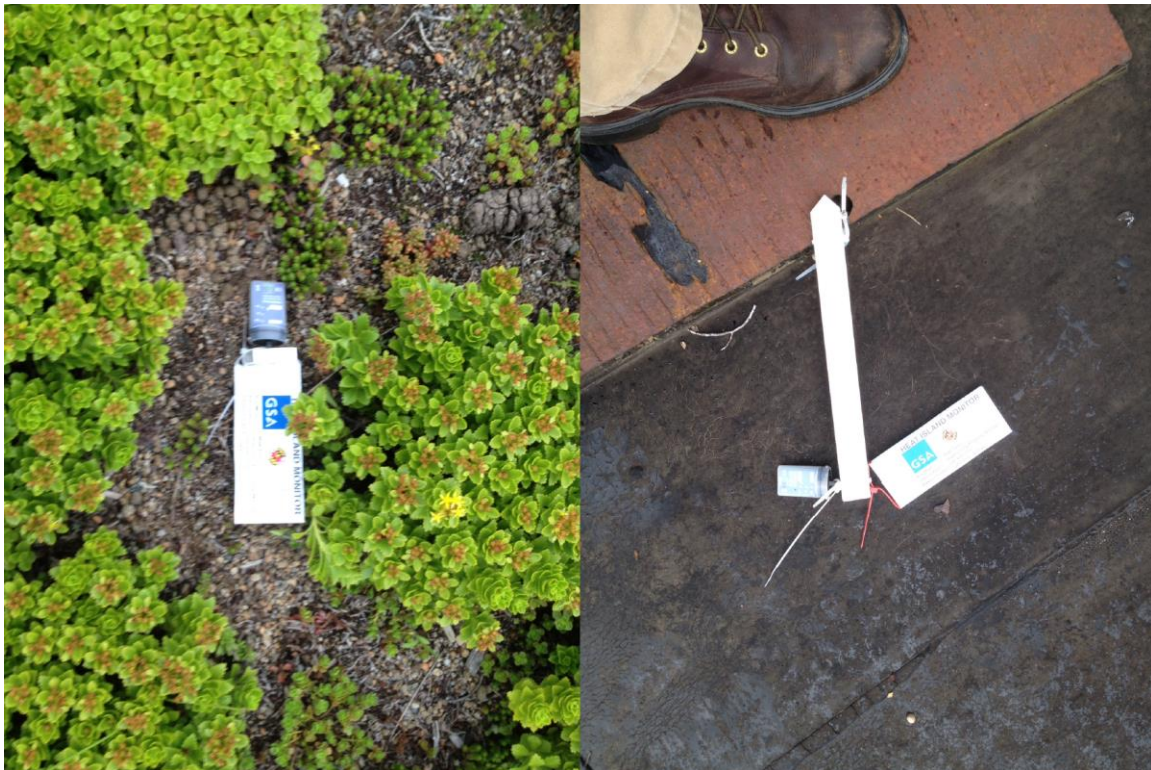
Figure 5 – Data loggers on surfaces.

Left: Temperature Logger on Sedum Greenroof.

Right: Temp Logger on Flat Black Roof

For this study, surface temperatures were used because of an interest in how surfaces affect human comfort and impact UHI. Surface temperatures were measured for seven different surface types: traditional flat roof, concrete, courtyard stone, courtyard planting bed herbaceous, courtyard planting bed trees, green roof sedum, and green roof tall grass. Surface temperatures were measured using HOBO temperature pendant data loggers (UA-001-08). For the initial monitoring period, the loggers were installed in 2" PVC end caps for

shading with two rows of 1/4" holes drilled in them and about 3/4" between rows to allow airflow while protecting the logger from solar radiation. Inside the housing, the logger was suspended horizontally about 1" off the surface. Logger housings were secured in place using zip ties and 1/4" x 1 1/2" solid PVC stakes driven 6" into the ground. On the stone, concrete, and asphalt surfaces, data loggers were installed on the edge of the surface to allow the stakes to be driven into adjacent soil. This was done to minimize potential for disturbance by foot traffic and maintenance activities. The location may bias the surface measurements to be impacted by the adjacent land cover, but close proximity of the logger to the intended surface, ~1", may minimize this effect. Data loggers located on soil were sited towards the middle of the assigned surface. Loggers were installed on 5/12/2015 and set to sample every hour (see figure 5).

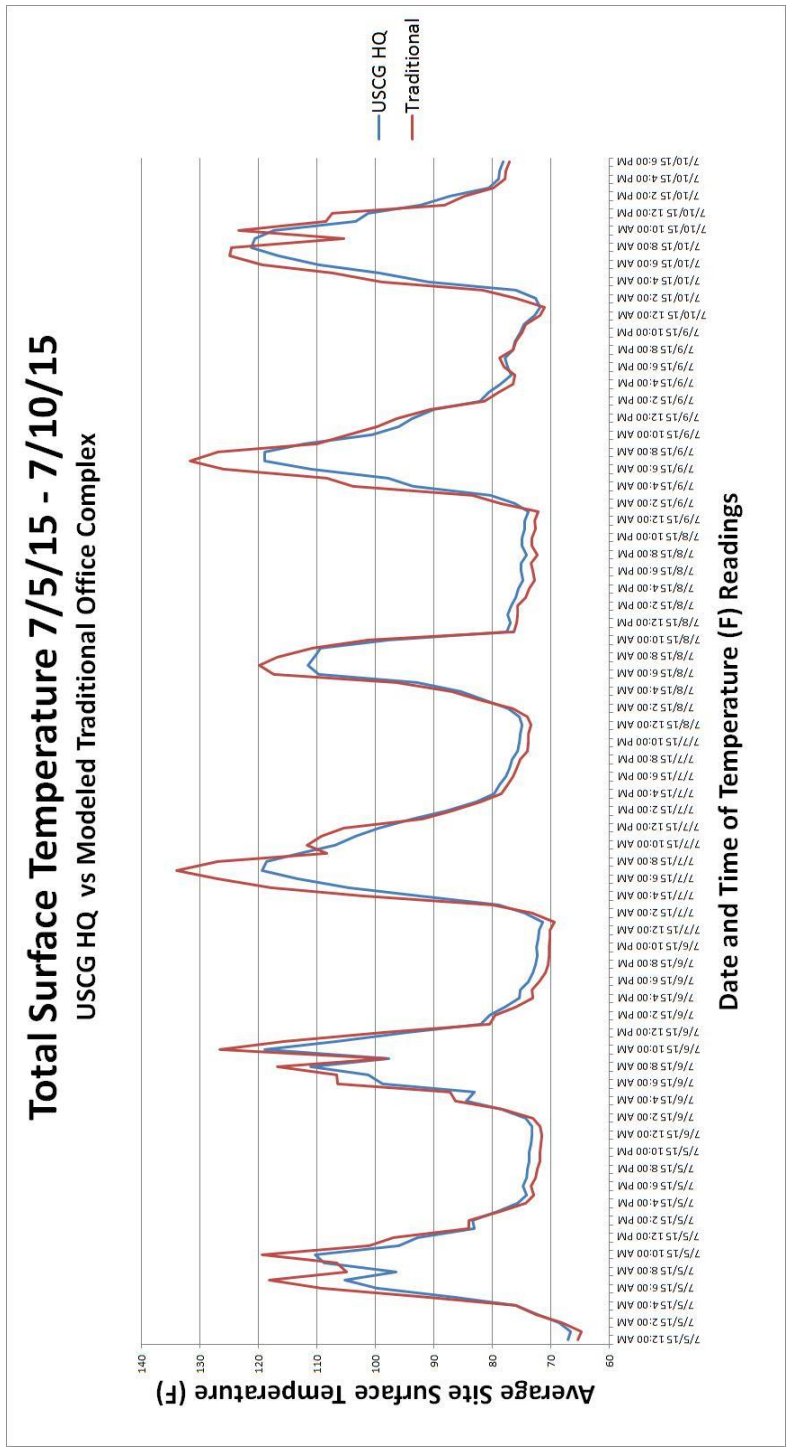
Figure 9 - Graph of average weighted surface temperatures.

From 7/5/2015 to 7/10/2015, the weighted average surface temperature for the Coast Guard headquarters was 86.7° F while the traditional office complex was 88.3° F — an average difference of 1.6° F. This value is nearly within the range of the annual mean temperature differences between dense urban areas and their surroundings, as reported by the U.S. EPA. The differences ranged from 2° F in the late evenings/early mornings where the traditional site reported cooler temperatures, to 15° F during midday when the traditional office complex was much warmer — meaning, the traditional office complex had a more extreme temperature range and was warmer on average than the U.S. Coast Guard headquarters (see figure 9).

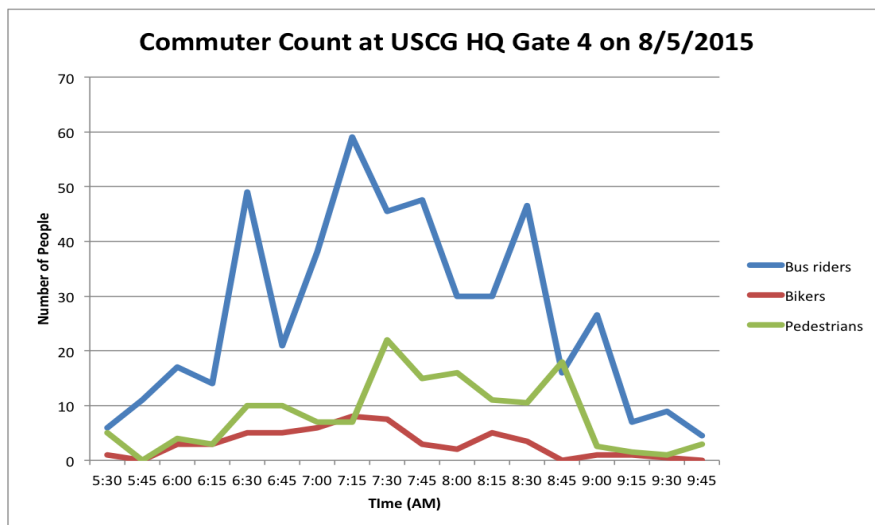
Figure 10 – Transit, bicycle and pedestrian commuter counts.

The U.S. Coast Guard headquarters design provides access to the site on shared use pathways (bicycle and pedestrian) and covered bus transit stops in addition to vehicular access. There are multiple bus routes that serve the site during commuting hours, with the most common route connecting to the local DC Metro stop: Anacostia. To quantify the non-vehicular (except bus transit) commuter traffic, a morning commute traffic count was conducted looking specifically at bus riders, cyclists and pedestrians (see figures 10 and 11).

The bus stop and shared use path enabled 478 employees to commute daily on public bus transit, 55 employees by bicycle, and 147 employees on foot. A total of 679 people arrived at the site by these alternative modes of transportation. The peak arrival time was 7:30-7:45.

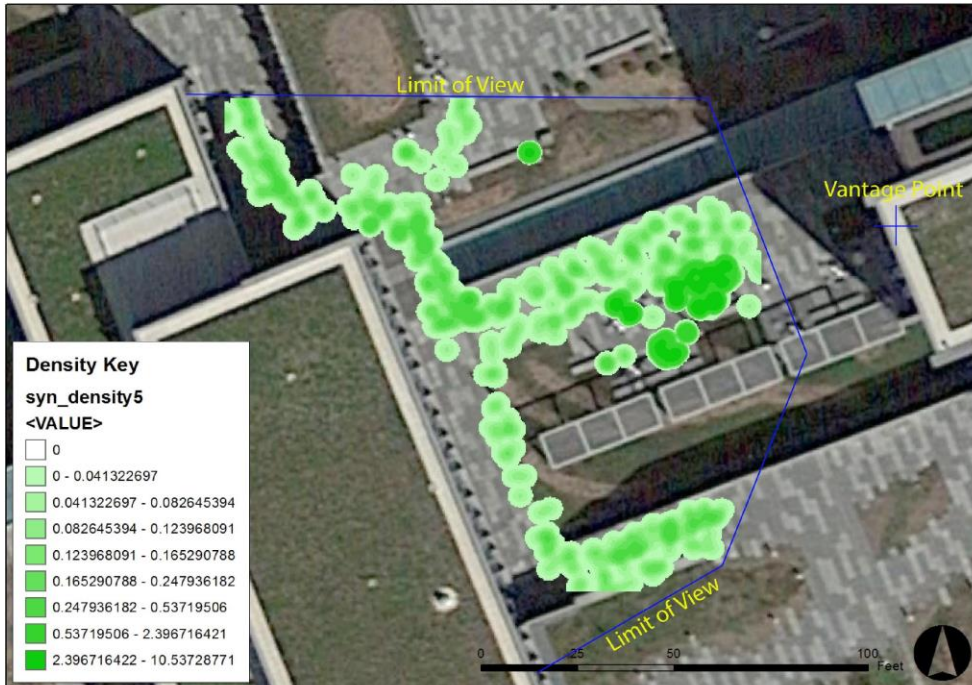
Figure 16 – Kernel density analysis of courtyard use.

A site plan of the courtyard was georeferenced into ArcMap. A new point file was created with a field for frame number and a field for pose, standing or sitting. Use observed in each frame was then digitized into GIS using points. A Kernel Density Analysis was completed for one morning, lunch, and afternoon frame to create raster heat maps representing use density. A synthesis heat map was also created in ArcMap, including the points from all frames (see figure 16). Cell size was set to 0.1' and search radius was set to 1'. The densities were organized into colors using quartiles in symbology. The intervals were then rounded to the hundredth decimal place for ease of understanding. Movement patterns and gathering points were analyzed using the synthesis heat map. The darkest areas near the metal trellis represent major lunch seating areas while lighter colors represent movement patterns.
